Independent Oil and Gas Company Phillips 66 Service Station Route 66, Baxter Springs, Kansas

Introduction

The preliminary draft of this report was written and compiled in February of 2007, and the final draft completed in April of 2007, by the architect, Mike Kertok. Mike Kertok visited the site in September and October 2006 to inspect and record the existing condition of the Independent Oil and Gas Company / Phillips 66 Service Station building, and performed a follow-up visit in February 2007. The building was measured and photographed in order to generate the drawings contained in this report. The building was thoroughly inspected to determine its current condition and original construction, and to formulate a plan for rehabilitation.

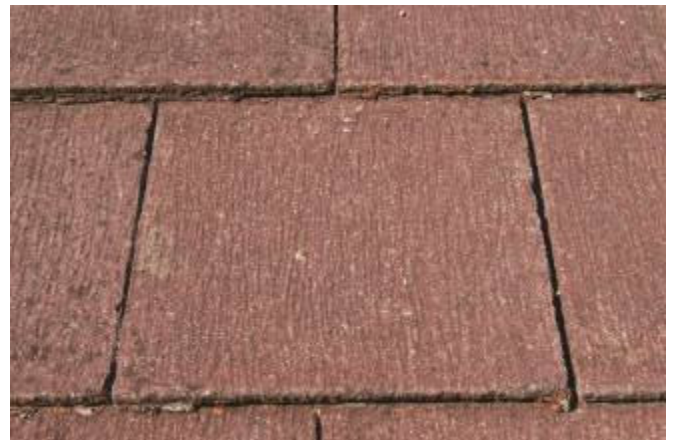
The gable roof on building is covered with the original asbestos-cement shingles, many of which are now over 75 years old. Asbestos-cement was a very durable roofing material and it is not unusual to find such roofs of this age still in serviceable condition. Asbestos-cement shingles are “non-friable”, and they pose no hazard as long as they are not disturbed (i.e. broken, drilled, cut, etc.). Another possible source of asbestos is the stucco plaster.

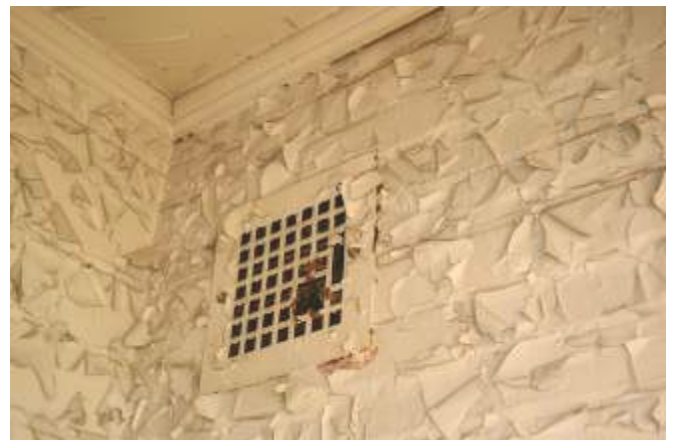
Although no testing has been done, it is likely that much of the paint on the building, exterior and interior, contains lead. The paint in many areas is cracked and peeling. Appropriate procedures will have to be used to remove and dispose of the old paint. If the paint can be removed by scraping, the procedures are relatively simple and easy to accomplish. If sanding is required, then areas will have to be isolated, the dust collected and filtered, and workers will have to be provided with adequate masks, among other procedures. Refer to State and National EPA requirements for details.

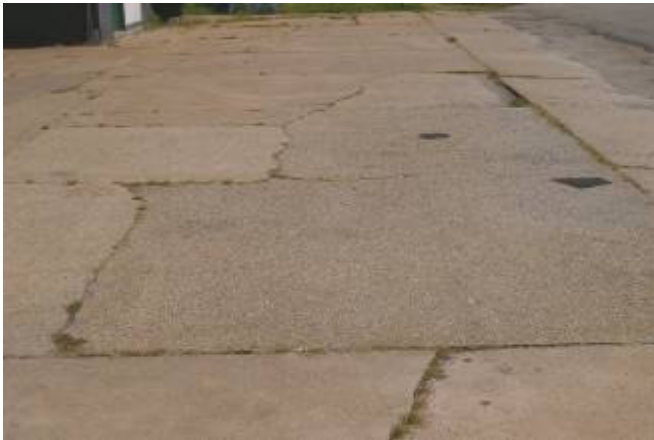
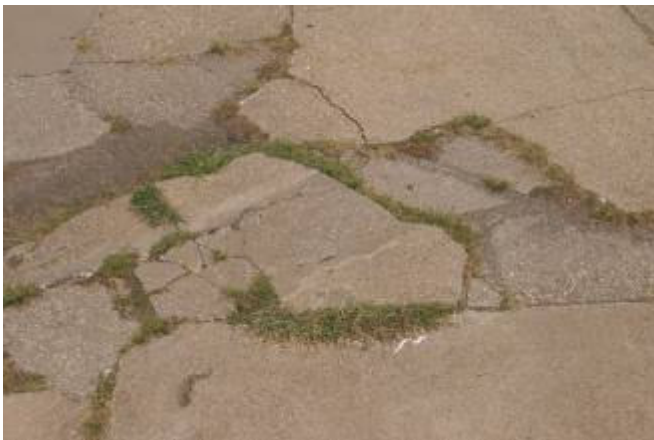
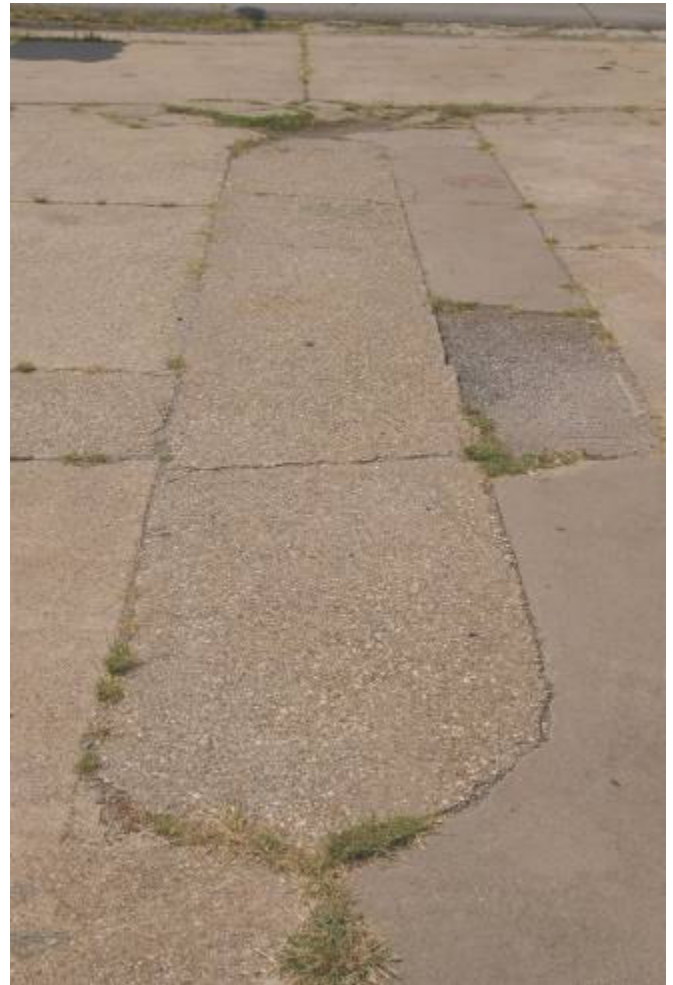
Concrete paving extends from the south side of the building to 10th Street and from the east edge of the building to Military Avenue. The concrete site paving is in fair to poor condition. There are numerous cracks in the paving and vegetation has invaded and is growing through many of the gaps.

The original concrete pump island is gone, but its outline can still be seen in the paving.

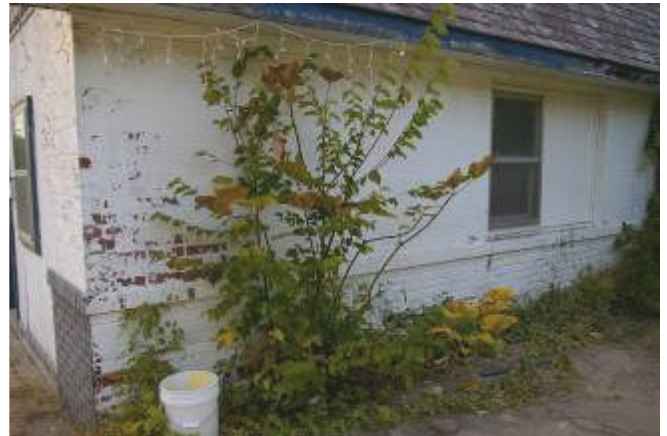
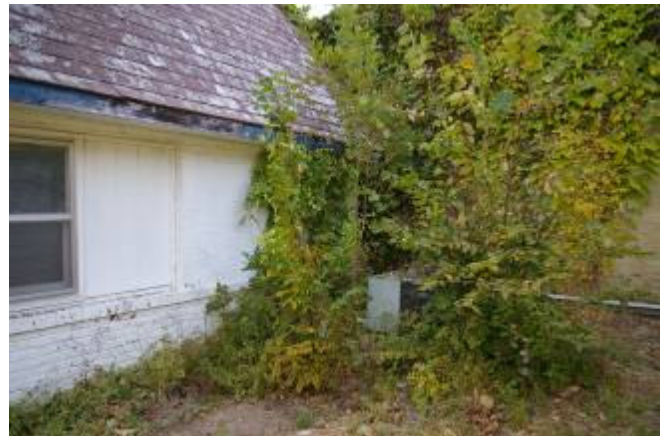
During the initial inspections, there was significant growth of thick invasive vegetation along the east side of the building, and, to a lesser extent, on the north side. The vegetation was removed during the winter of 2007 (see photo on previous page for comparison). The plants do not appear to have caused any structural damage.

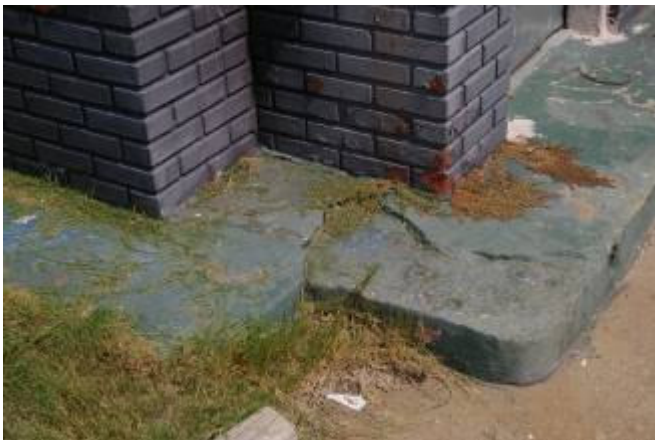
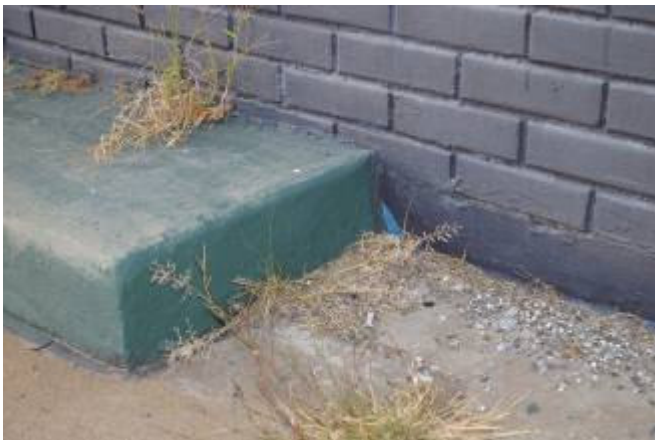
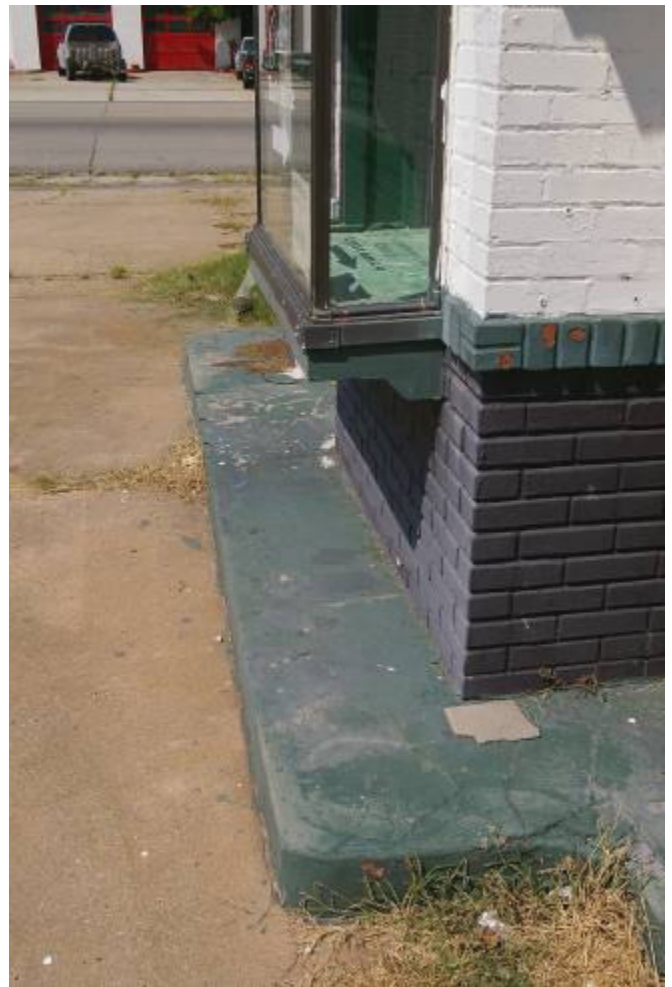
The building's concrete foundation appears to be in good condition with no cracks or uneven settling observed.

The narrow, raised concrete sidewalk wrapping around the south and west sides of the original building is in fairly good condition, with some cracking and spalling at the southwest corner. There is also some invasive vegetation growing through gaps and cracks.

At two points on the south side of the building, round drainage pipes open on to the top of the sidewalk next to the building for connection to downspouts. The drainage pipes elbow 90 degrees under the sidewalk and empty onto the site paving from round outlets in the face of the sidewalk. The drainage pipes appear to be in serviceable condition.

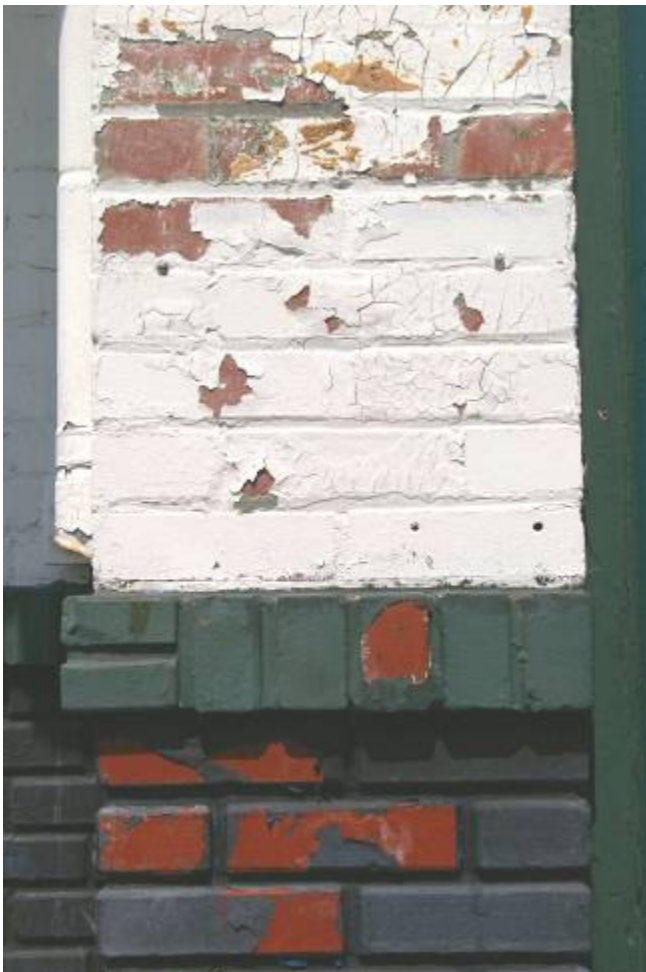
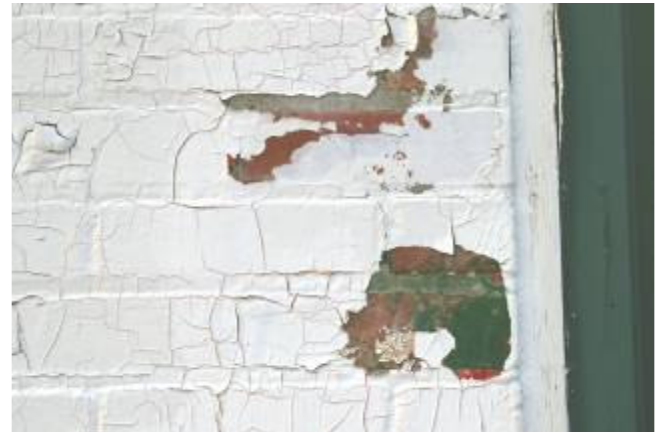
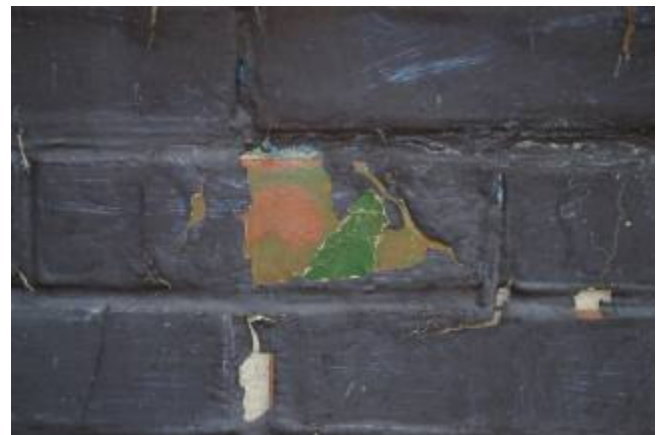
Masonry bearing walls of the original building and the addition are approximately 8 inches thick, laid in a common bond pattern. Both the face brick in the upper portion of the walls and the molded brick in the lower portion appear to be in good condition. Mortar joints appear to be sound with no visible joint separations.

Several layers of paint have been applied to the masonry over the years. The condition of the paint varies, with good adhesion remaining in some places and with significant peeling and flaking in other places.

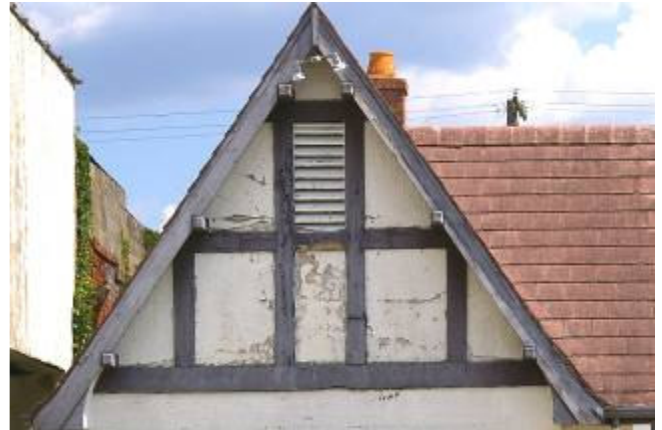
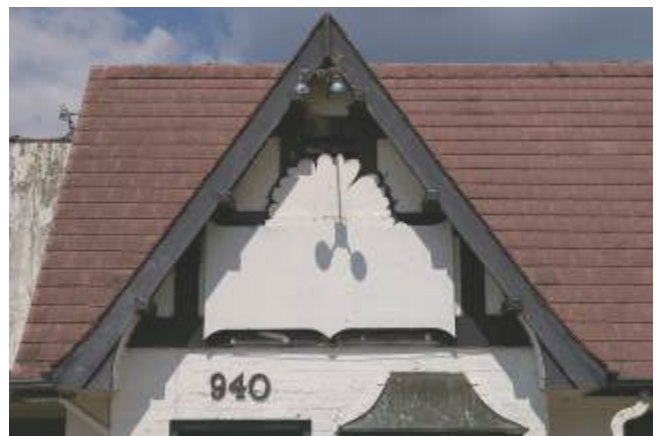
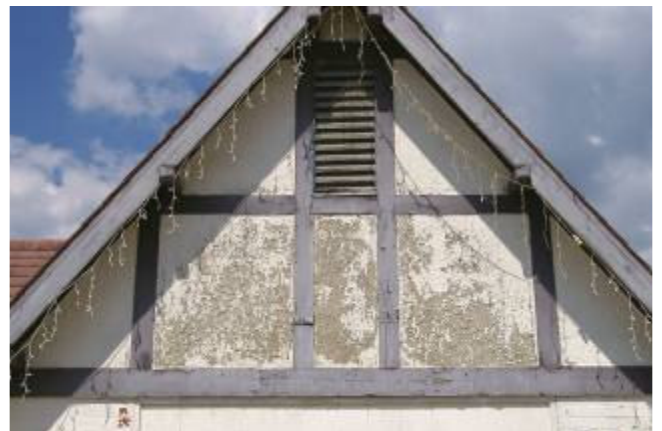
The stucco and timbers in the three visible gables of the building are in fairly good condition. (The fourth gable on the north side of the garage is constructed of brick.) The stucco appears to be sound and well adhered. No significant cracking or loss of adhesion was observed. There is some minor surface deterioration, mostly on the west gable.

Paint on both the stucco and timbers is deteriorating. There is significant flaking of paint from the stucco over the garage door.

The wood attic ventilation louvers in each gable show more significant weathering, especially those above the garage, where several slats are very badly deteriorated.

A sign board, not original to the building, obscures much of the gable over the main entrance of the original building, preventing inspection of that area.

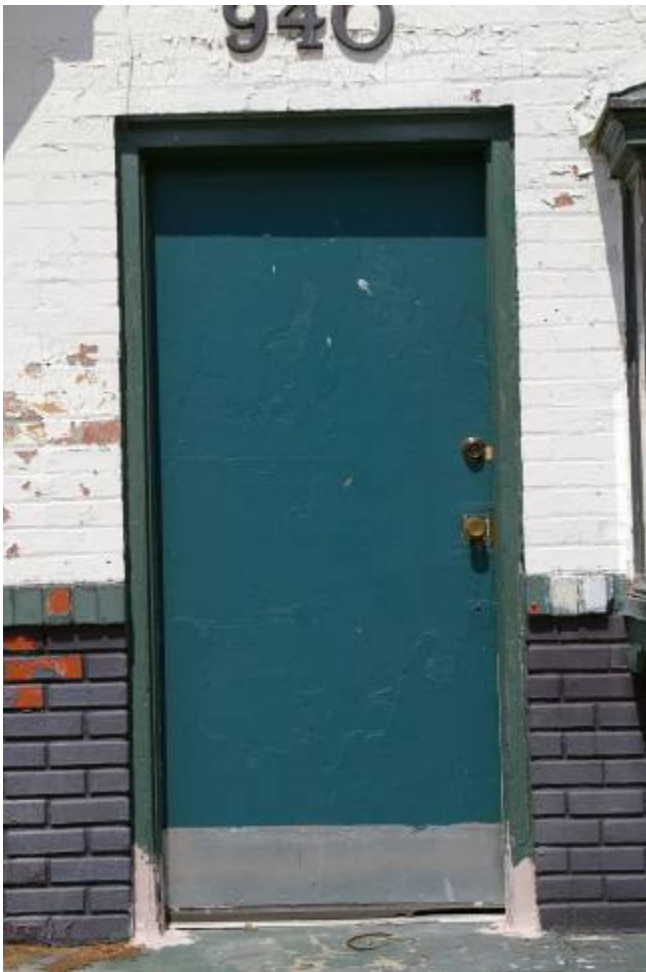
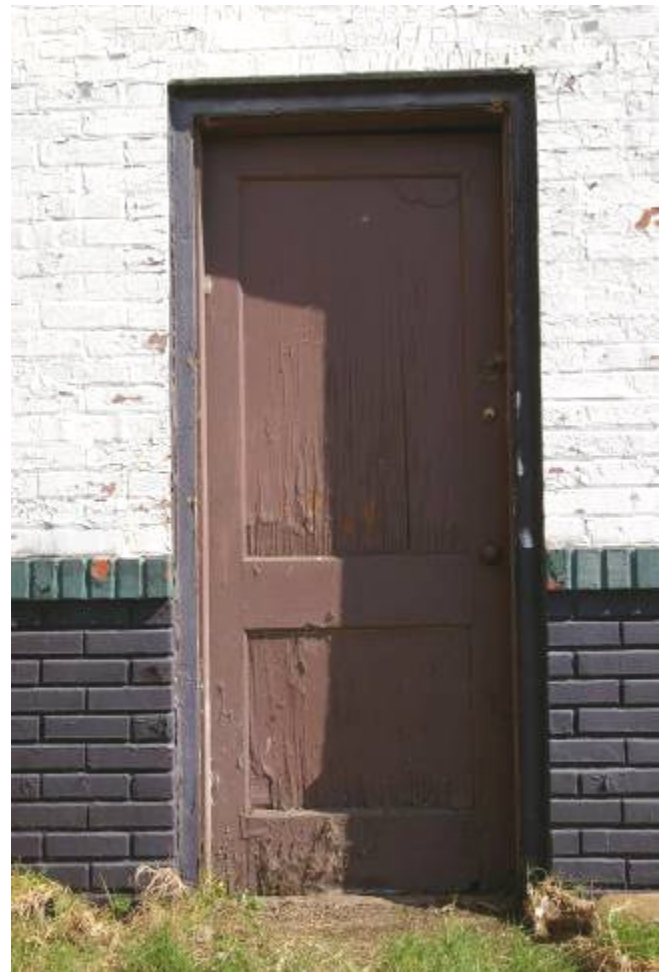
The front door on the south side of the building is not original to the building. The original door was a stile and rail wood door with a single cross-braced wood panel below and nine divided lights above in three equal rows of three. The existing wood door frame is probably original. It is in generally good condition, but with obvious repairs to the bottom of the jambs, where one would expect deterioration due to moisture exposure.

It is not known for certain if the ladies' room door on the west side of the building is the original door. It is a wood stile and rail door divided horizontally into two panels. The door is in poor condition, with significant weather damage to the panels, bottom rail, and bottom of the stiles. The wood door frame is in fairly good condition, with some moisture damage at the bottom of the jambs.

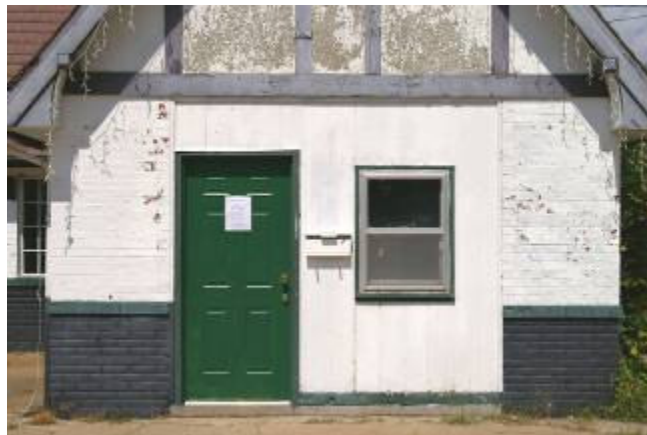
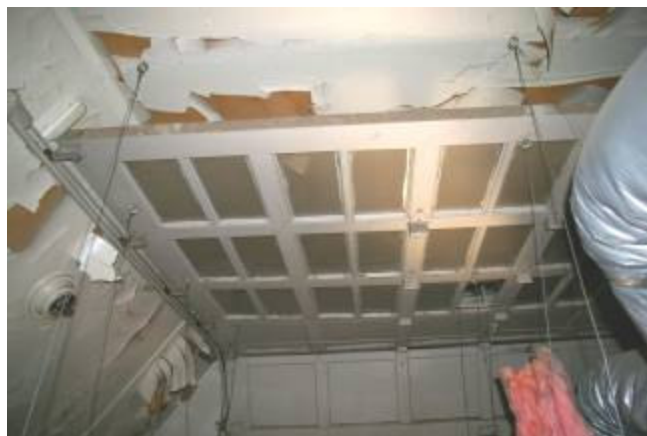
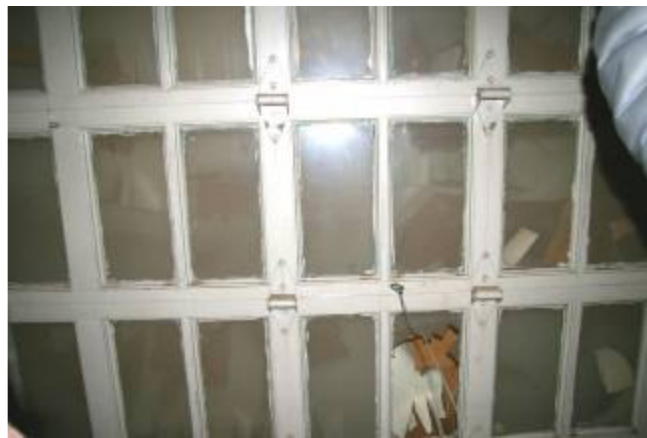
The original garage door opening has been infilled with framing and surfaced on the exterior with painted wood paneling. The infilled area contains a man door in a hollow metal frame and an aluminum double-hung window, both of which are in good condition.

The original garage door is apparently intact and stowed in its open position within the building above a lay-in ceiling. Close inspection of the garage door was not possible, but it appears to be in good and serviceable condition, with most of its original glass intact. The garage door was a manually operated overhead sectional door of wood frame construction.

The horizontal portions of the door tracks are intact, but the vertical portions of the track on either side of the door opening have been cut and removed.

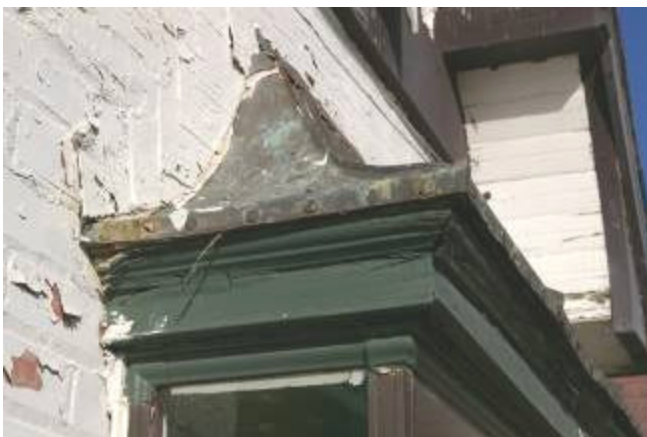
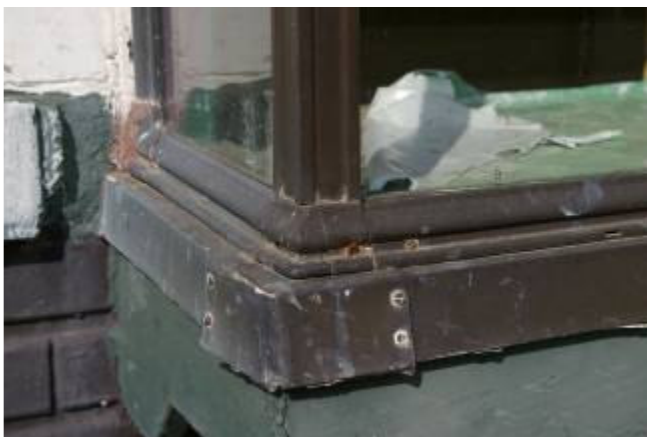
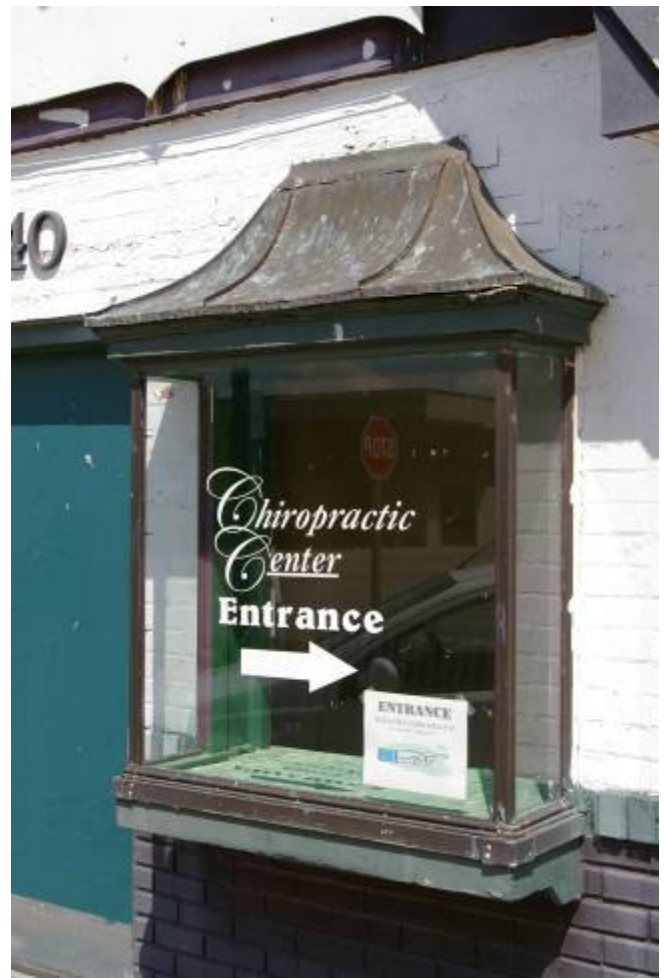
The showcase window is in generally good condition. There is some visible weathering of the wood crown and some separation at the joints in the wood. The copper window frame is in good condition and the glass is intact. Other than two missing nails, the copper roof and flashing are also intact and no evidence of water infiltration was observed. All of the copper has developed a dark patina. The sign painted on the window is a recent addition.

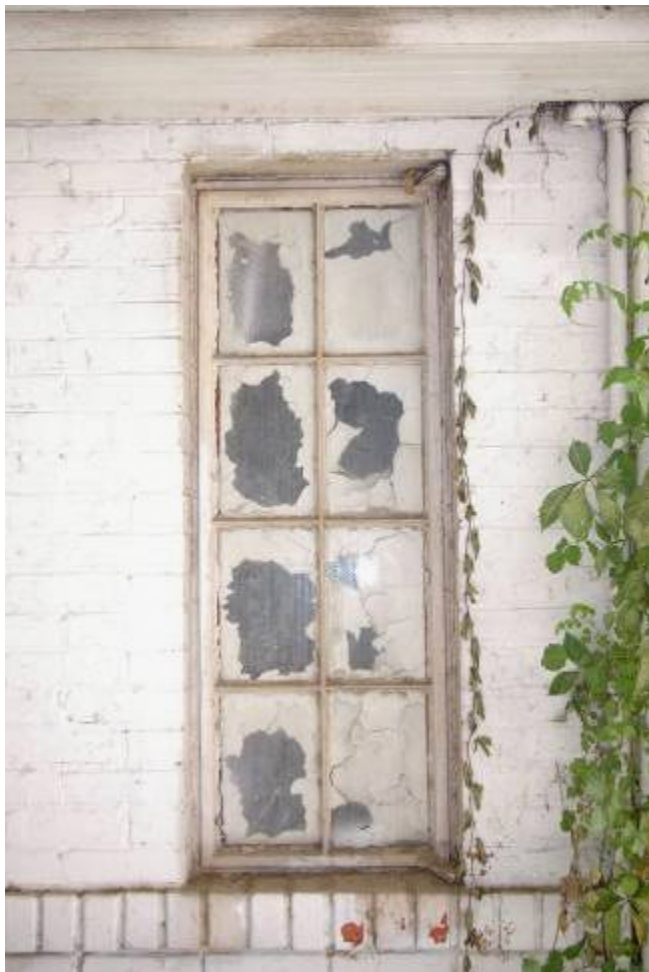
Ladies' room window

Two single-leaf steel casement windows open into the men's and ladies' rooms on the north side of the original building. Each window is two panes wide by four panes high. The steel frame of the ladies' room window appears to be in good condition and the patterned glass is intact, but largely covered with paint. Glazing putty and paint are deteriorated. Paint build-up on the hinges and latches render the window inoperable.

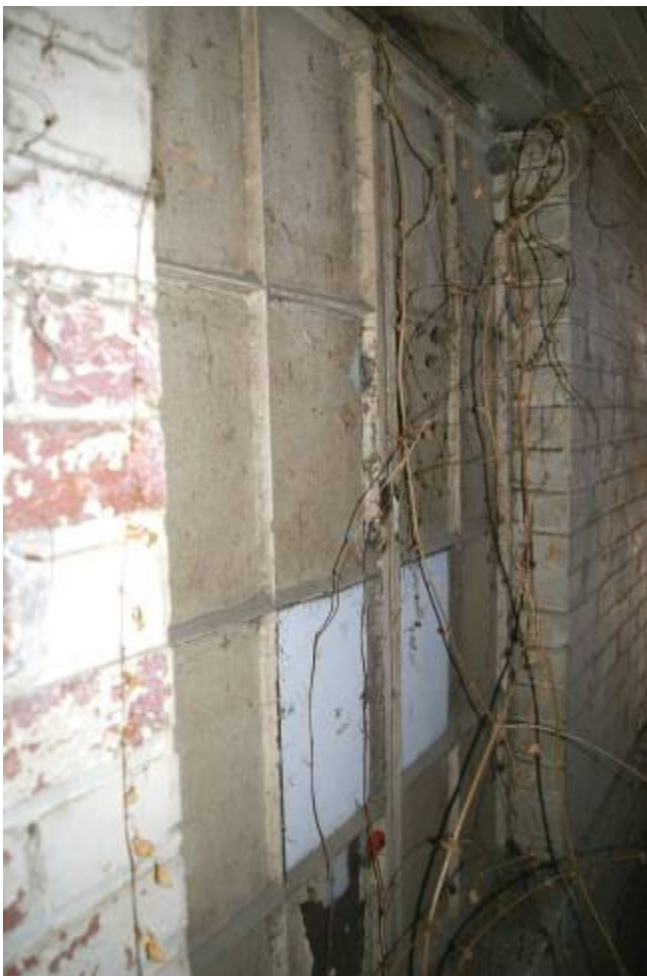
North office window, original building

There is another double-leaf steel casement window on the north side of the building, opening into the original office area. The glass has been painted but is intact. The latches are missing and the casements have been welded to the window frame.

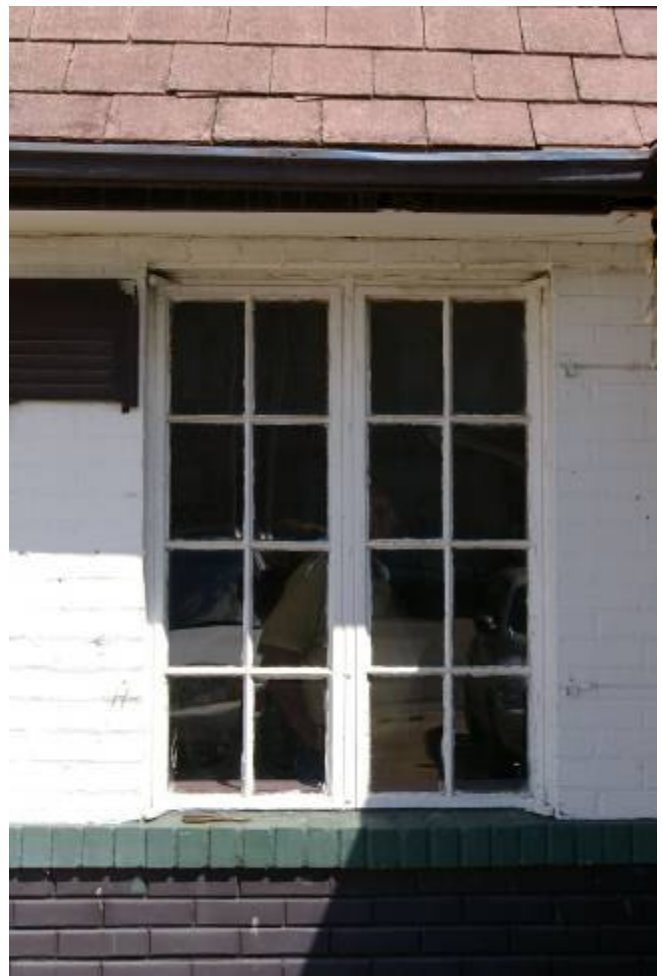
South window, addition

A double-leaf steel casement windows on the south sides of the addition matches the double-leaf casement windows on the original building. The steel frames appear to be in good condition and the glass is intact. Glazing putty and paint are deteriorated. Paint build-up on the hinges and latches render the windows inoperable. A portion of a decorative plastic shutter that remains adjacent to the window is not original.

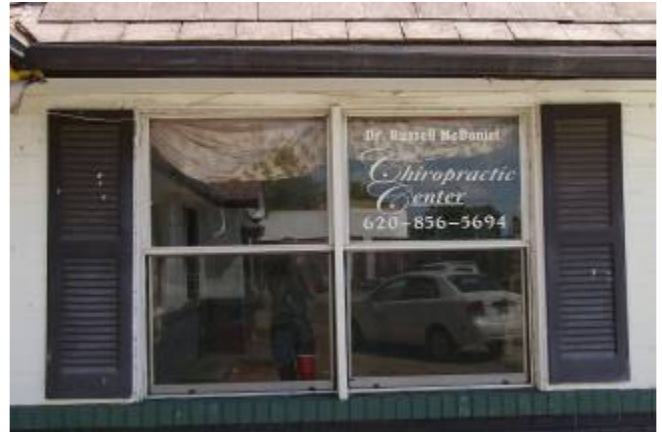
West garage window

On the west side of the garage are two aluminum double hung windows in a single opening. On the east side, there is a single aluminum double hung window which fills half of a larger opening, with the remainder of the opening walled in and surfaced on the exterior with painted wood paneling. These aluminum double hung windows are in good condition, but are not original to the building. The decorative plastic shutters on either side of the west window are also not original.

The original windows were likely multi-paned steel windows. They may have been casement windows or they may have been fixed (non-operating).

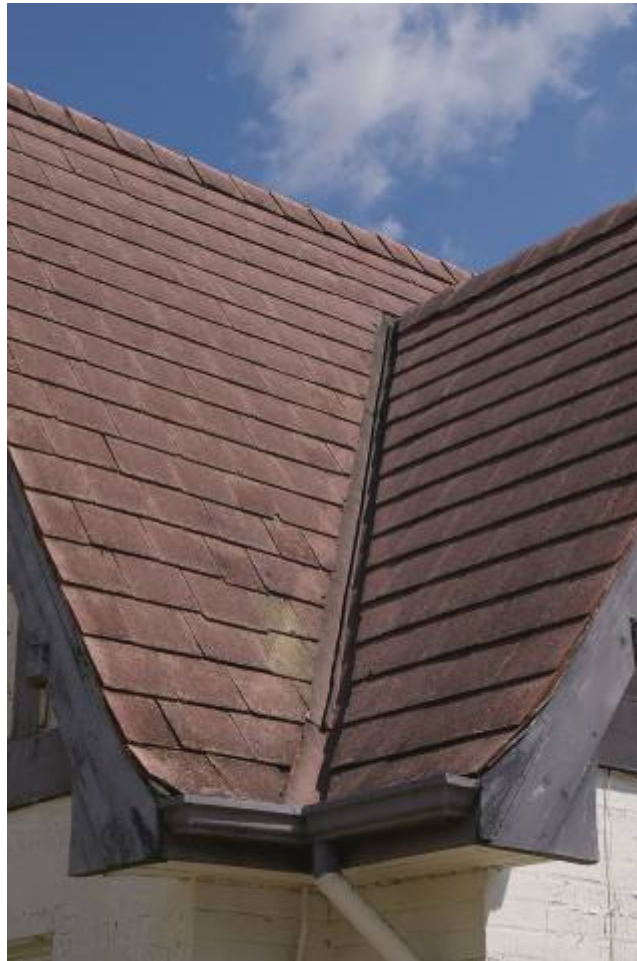
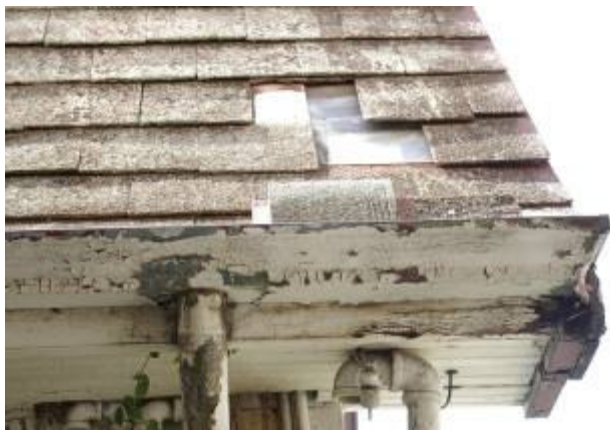
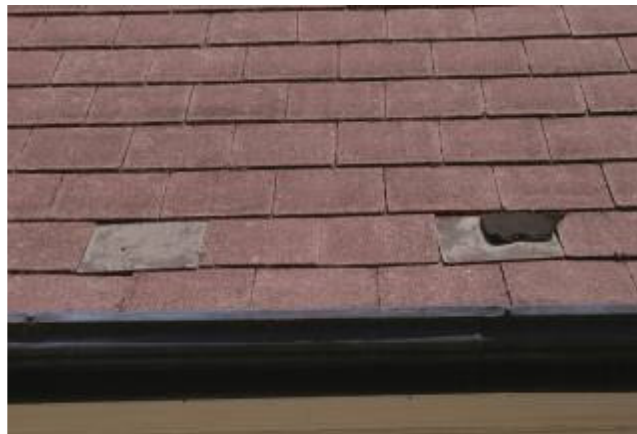
The shingles are in generally good condition. Several shingles are loose or missing near the northwest corner and at the bottom of the valley over the inside corner of the addition. A couple of shingles have been replaced near the eave on the south side with a non-matching color. There are some gaps in the shingles on the east side of the garage which expose the decking beneath.

The shingles have been painted over at least twice, but the most of the paint has either worn away or been removed.

The roof valley flashing appears to be in good condition and no evidence of leaks was observed.

Replace missing and damaged shingles. If matching shingles are not available, use shingles from the north side of the roof to replace shingles in more visible areas and install mismatched shingles on the north side. Observe proper handling and disposal procedures when working with asbestos-cement shingles. Seal gaps in shingles on east side of garage. Repair flashing around the chimney of the original building and cap the tops of the chimneys if needed. Clean paint remnants and moss from shingles on the north and east using gentlest means possible such as chemical cleaner, stiff bristle brush, and/or low pressure wash. Do not sand blast.

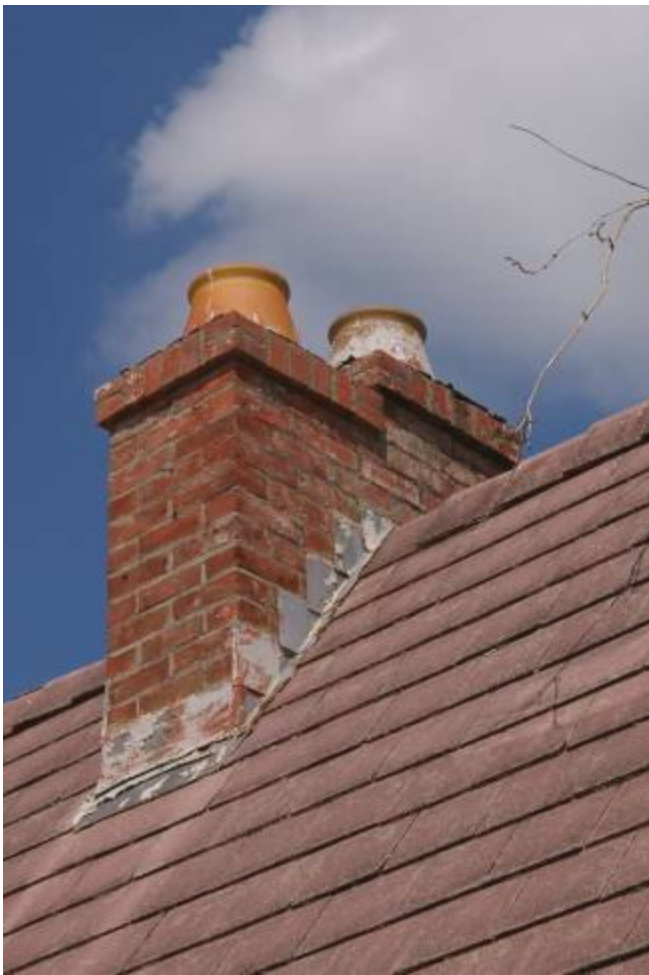
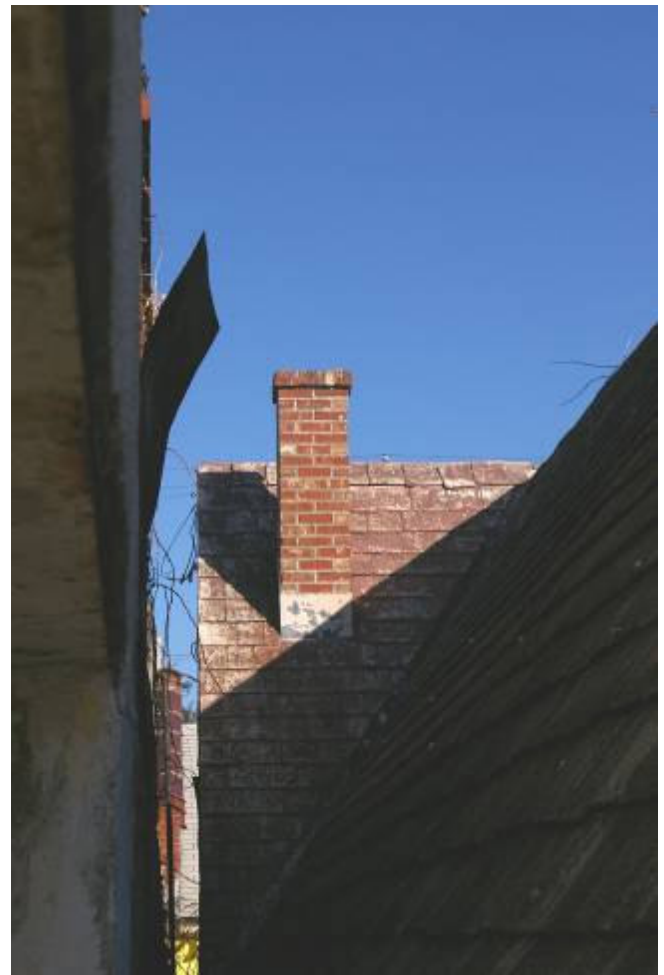
The chimney of the original building was originally on the exterior of the east wall, but was largely engulfed by the addition. The top of the dual chimney protrudes through the roof at the ridge and is topped by two terra-cotta chimney pots. The masonry appears to be in good condition with some remnants of paint present. The owner reports some leaking in the area of this chimney, so some repair of the flashing is likely required.

The garage chimney rises along the north wall of the building and penetrates the east side of the garage roof. It is a simple brick chimney and it appears to be in good condition, although it was inaccessible for close inspection.

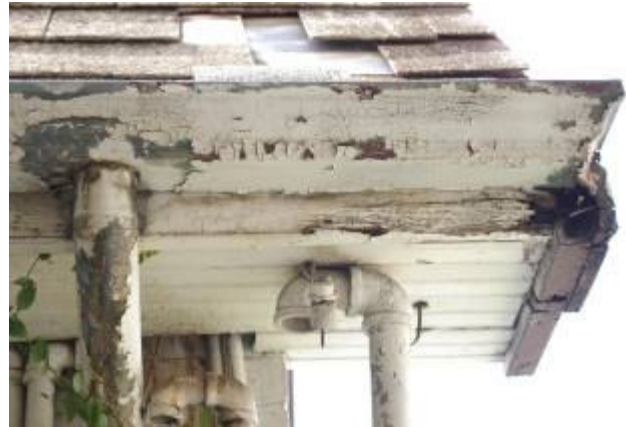
Soffit and trim at northwest corner of building

The beadboard soffits are generally good but weathered in places and the plywood garage soffit is in fair condition. There is a sizeable hole in the soffit below the inside corner of the addition. Gable and eave trim condition varies from good to poor, with the most significant weathering occurring at the northwest corner of the building and along both sides of the garage eave.

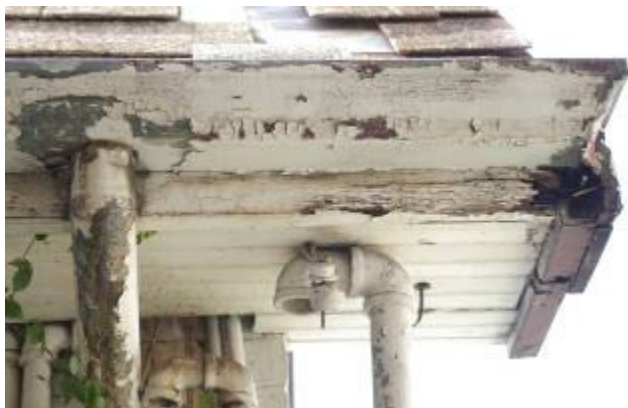
Gutter and downspout at northwest corner

The sheet metal gutters on the original building are in good condition. The paint on the east and south gutters is also in good condition, but the paint on the north gutter has not been maintained and is in poor condition. The original downspouts are 2" diameter round pipe. The downspout at the northwest corner is intact, but in need of re-finishing. The upper part of the downspout at the southwest corner is in good condition but the bottom 3 feet is missing. The downspout on the south side of the original building has been replaced with a 4" x 3" sheet metal downspout and shifted over to allow for a decorative shutter.

Remove loose paint from existing gutters and downspouts. Replace missing section of downspout on west side of building and restore round downspout on south side of building. Install new gutter and downspouts on east side of garage of size, material, and profile to match gutter and downspout on west side of garage.

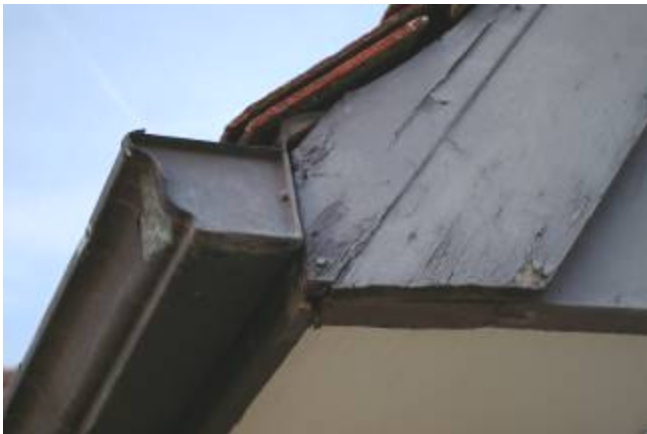
End of gutter on garage addition

The profile of the gutter on the addition matches that of the original building, although the end of the gutter is closed with a flat pan versus the mitered ends on the original building. The downspout at the southwest corner of the garage is 4" x 3" sheet metal. Gutter and downspout on the addition are in good condition and paint is intact.

There is not currently a gutter or any downspouts on the east side of the garage, and there does not appear to have ever been any gutters or downspouts on that side of the building.

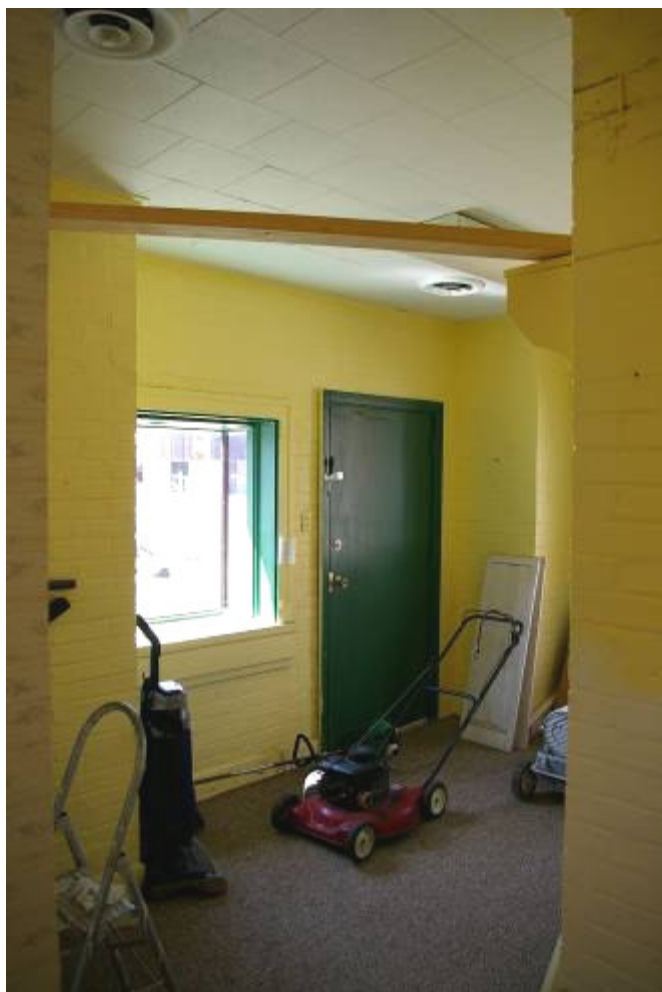
Office looking southwest toward front door

The office area of the original building has undergone some renovations. A wingwall partition has been added on the east side of the office space. It extends from the south wall and is crudely braced with a 2x4 to a wood shelf. The existing carpet flooring is in good condition. The original brick walls are virtually unaltered.

The original painted sheetrock ceiling is currently covered with 12x12 acoustical tile, which is in good condition. The fluorescent light fixtures and round air registers, which are in good condition, are also not original. Surface-mounted electrical conduit and outlet boxes are present on the east wall of the office. The opening to the chimney is covered by a round metal plate. An office heater would have originally been located within the room and vented into the chimney.

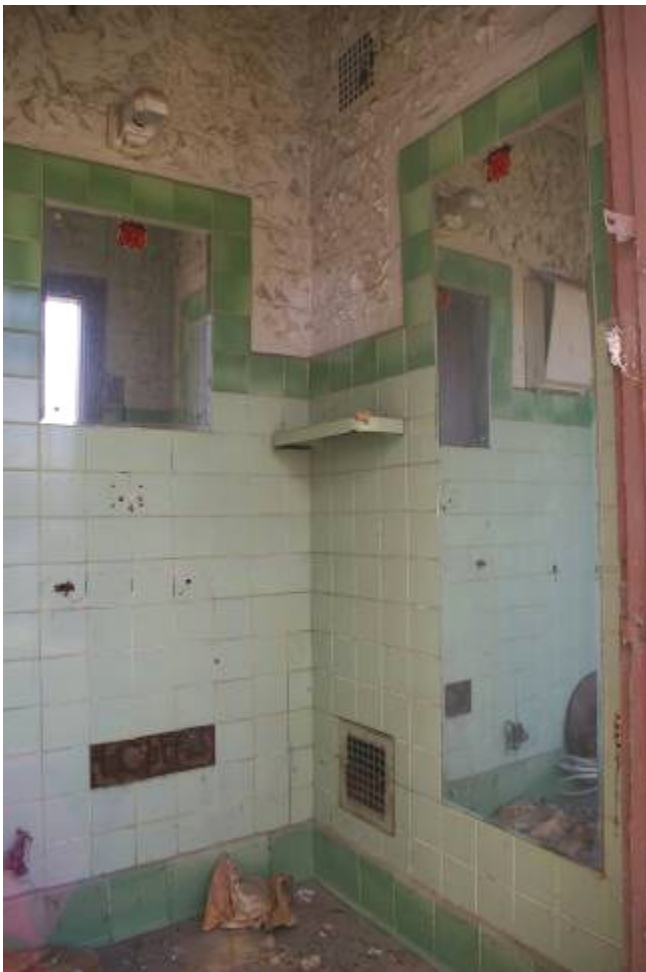
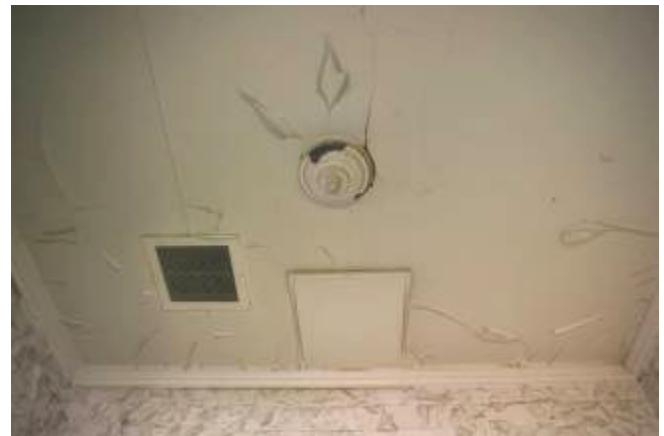
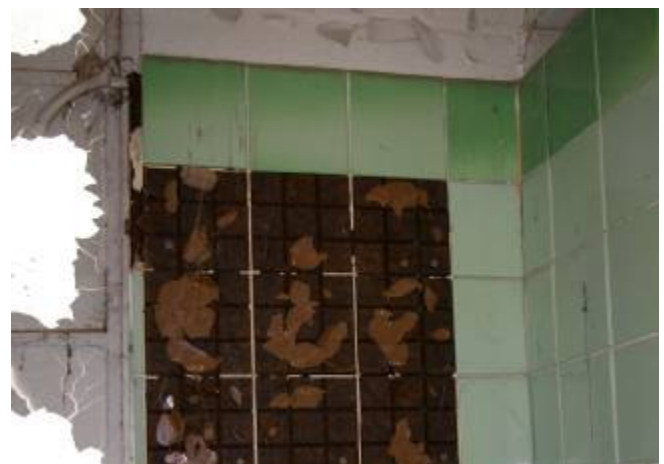
The former ladies' rest room has been boarded up for many years and is in generally poor condition, but apart from the lack of plumbing fixtures, it retains many of its original (or early) finishes and accessories. The floor is painted concrete. The 1943 Phillips 66 green wall tile is present, although some pieces are missing or loose. Paint on the masonry walls is peeling and in poor condition. The ceiling, presumed to be the original sheetrock, is in fair condition and the ceiling paint is peeling.

The exhaust grill and access panel are later additions. Only the collar of the original ceiling light fixture remains. The wall-mounted light fixture is either original or of early vintage and in very good condition. Accessories installed when the tile was installed include two mirrors with beveled edges, integral ceramic tile toilet paper holder and purse shelf. Two original air circulation grills penetrate the wall to the office area. Rust is visible on both and a small section of the upper grill has been cut and bent back.

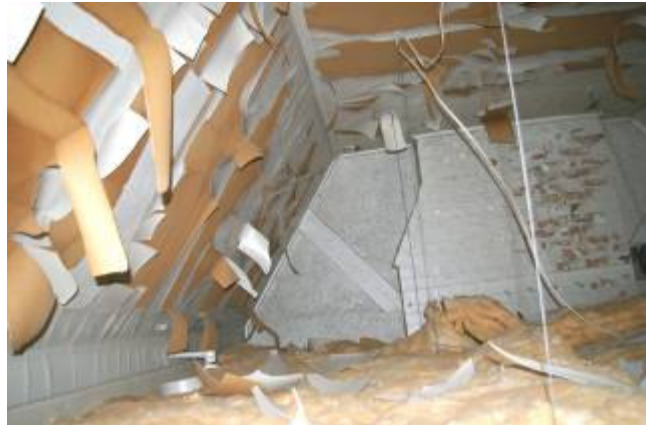
Original sheetrock ceiling

The existing carpet is in good condition and is installed over the original concrete slab. The painted masonry walls are in very good condition. The original sheetrock ceiling exists above the lay-in ceiling. It is in poor condition with much of the paint and paper facing peeling away. The original light fixture has been removed.

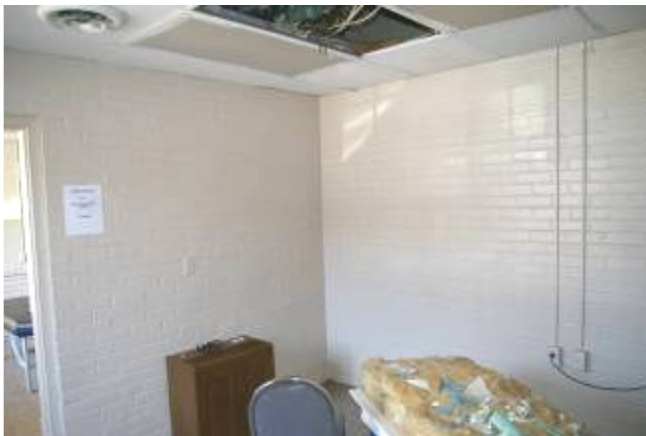
Garage NW area, looking northwest

The original garage space has been divided by partitions into three areas. In the northwest area, a raised plywood floor has been built over the original concrete floor slab to bring the floor level with the adjacent sales and display area. The floor is covered with carpet, which is in good condition. The painted masonry walls on the north and west are in good condition. The south masonry wall and the east partition are covered with wallpaper. Above the lay-in ceiling, the original sheetrock ceiling is in poor condition, although one original light fixture remains intact.

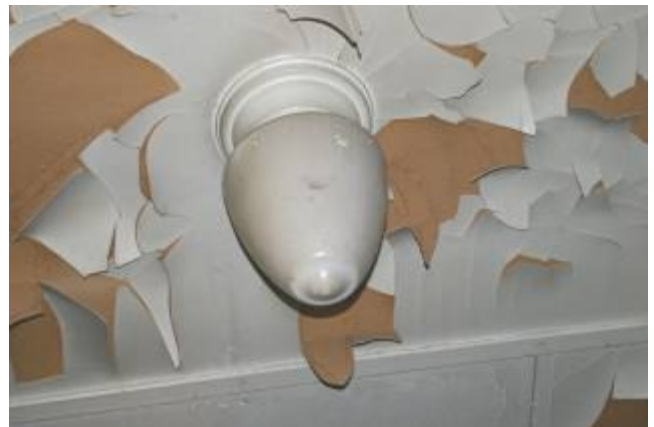
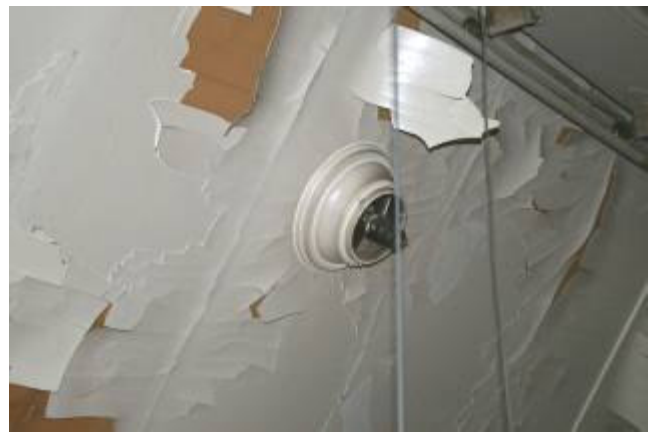
One original light fixture remains intact over the northwest area of the garage. It hangs from the horizontal portion of the ceiling and appears to be in excellent condition. In the southeast area of the garage, the collars of three light fixtures remain, two on the east side and one on the west side. They are attached to the sloped portions of the ceiling.
