National Register of Historic Places Registration Form

Historic name Gernon, Nicholas, House

Name of related Multiple Property Listing Post Rock Limestone Properties in Kansas: 1870 - 1948

Street & number <u>818 N. Kansas Street</u>	n/a	not for publication
City or town <u>Russell</u>	n/a	vicinity
State <u>Kansas</u> Code <u>KS</u> County <u>Russell</u>	Code _____	Zip code <u>67665</u>

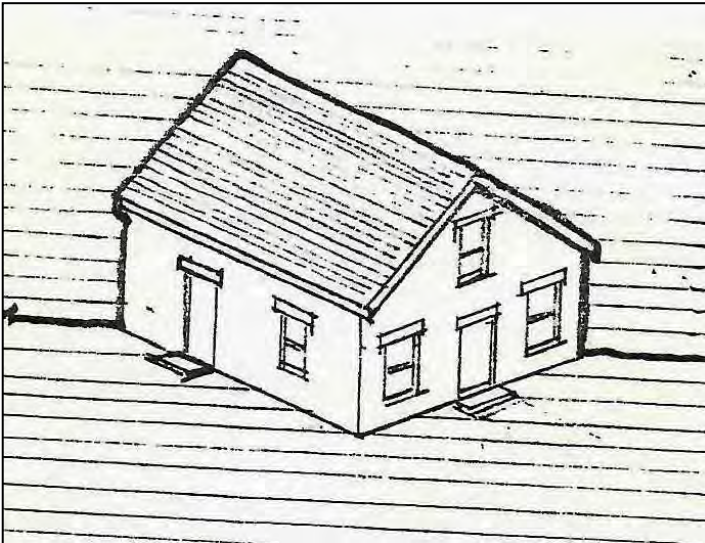
Phase One: The dwelling was originally constructed in a simple rectangular form in 1872. The original floor plan featured two rooms at the first floor and one room at the second half floor. There were seven windows and two doors at the first story, and two windows at the second story. The building was fully constructed of post rock limestone with decorative post rock lintels above the windows and doors. The roof was a gable style in an east-west layout. The dwelling was built with limestone mortar by the original owner, Nicholas Gernon.

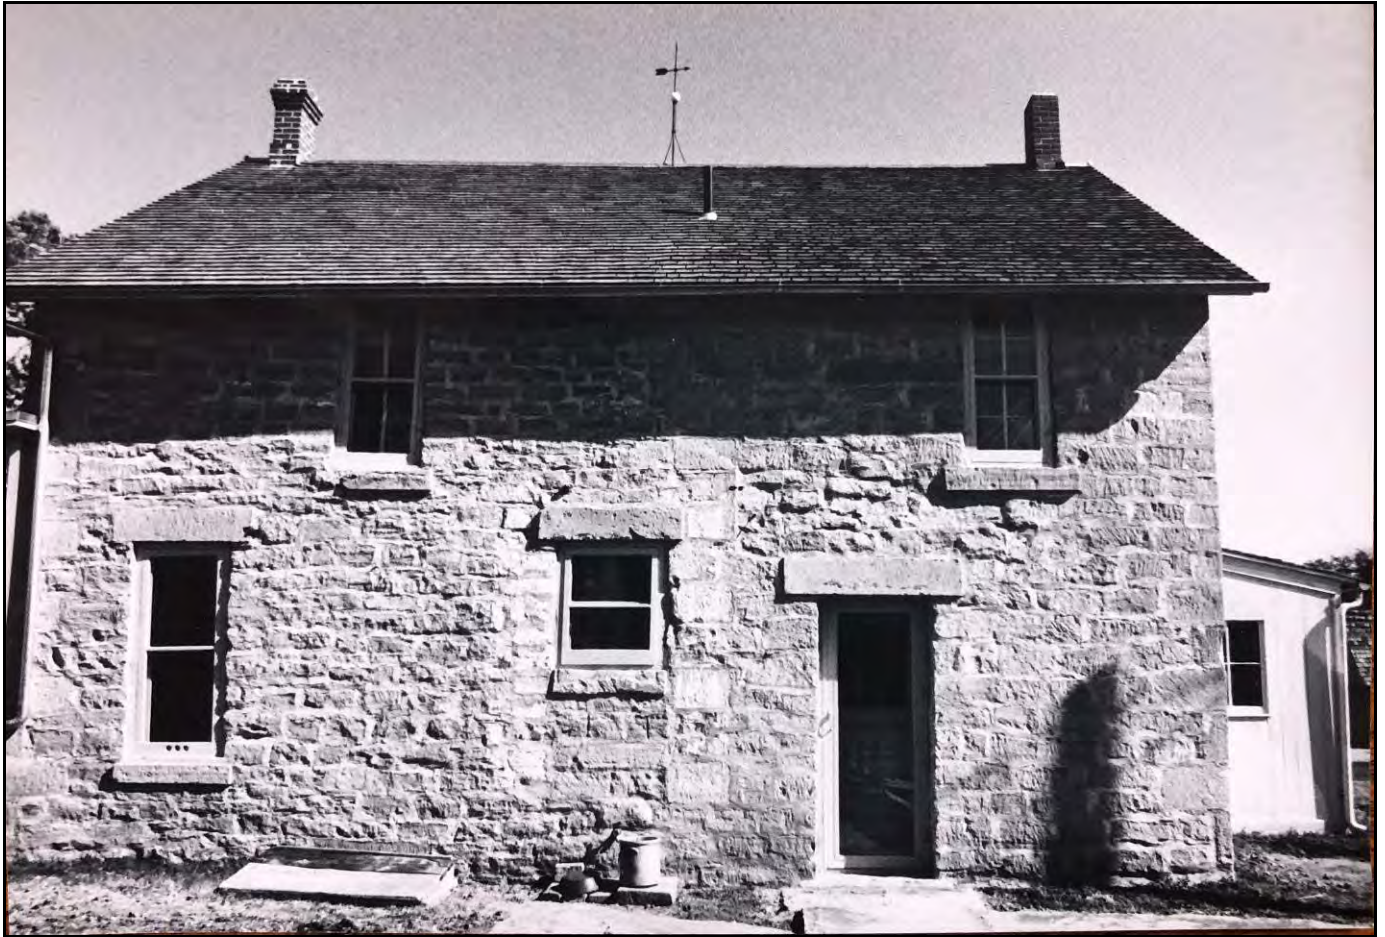
View of west elevation of Gernon House, 1981, after renovation. Photo shows the west elevation after the entrance at the center was removed and replaced with a window. The original side entrance was restored. Source: *Russell County Historical Society*.
