Independent Oil and Gas Company Phillips 66 Service Station Route 66, Baxter Springs, Kansas

Introduction

The preliminary draft of this report was written and compiled in February of 2007, and the final draft completed in April of 2007, by the architect, Mike Kertok. Mike Kertok visited the site in September and October 2006 to inspect and record the existing condition of the Independent Oil and Gas Company / Phillips 66 Service Station building, and performed a follow-up visit in February 2007. The building was measured and photographed in order to generate the drawings contained in this report. The building was thoroughly inspected to determine its current condition and original construction, and to formulate a plan for rehabilitation.

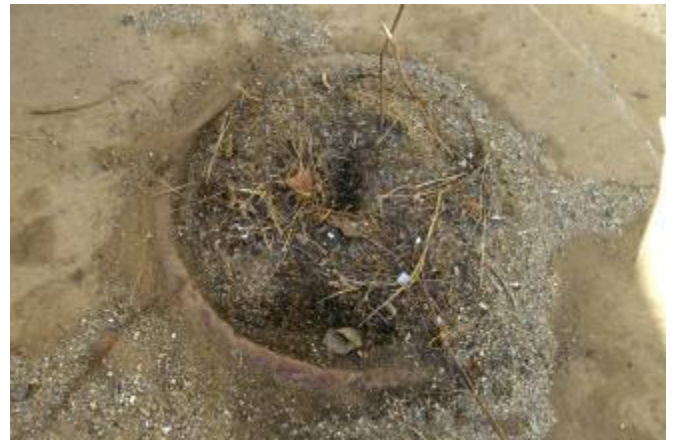
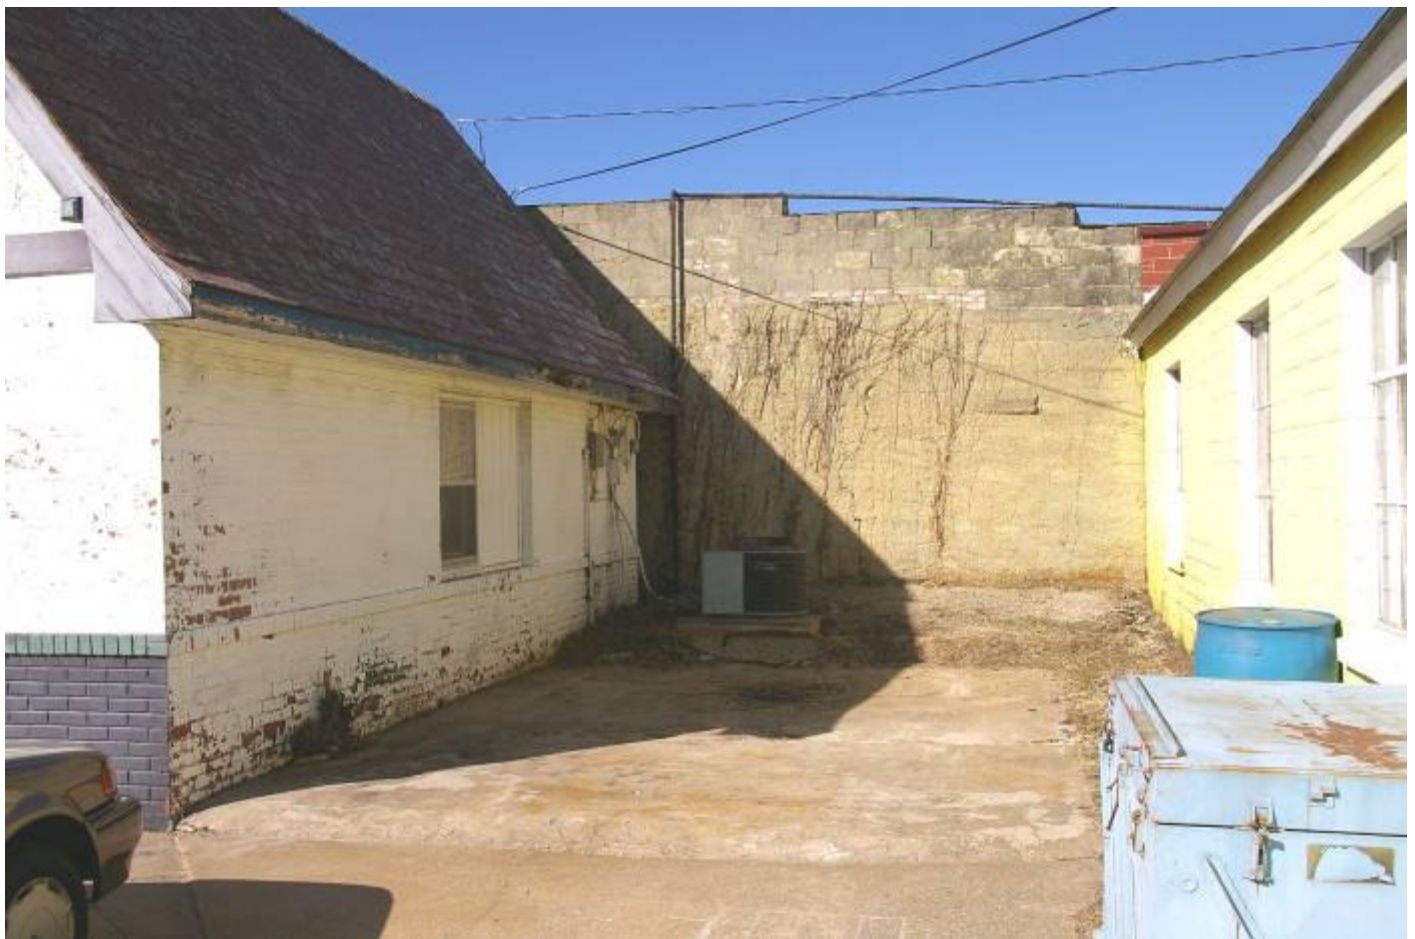
There is a raised concrete pad on the east side of the building. A large diameter metal ring is visible in the pad. This area may have originally contained an outdoor hoist. The concrete pad is in good condition.

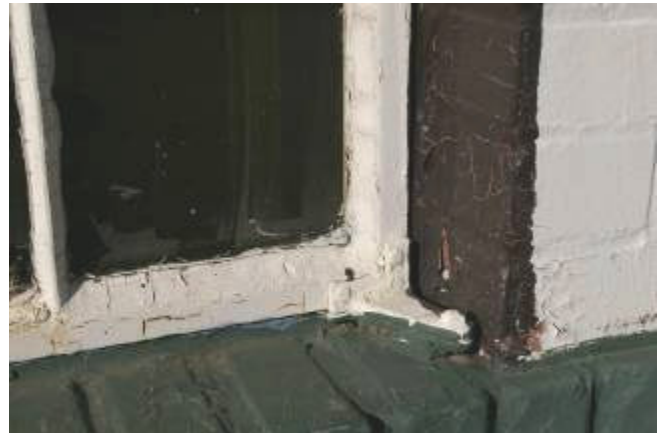
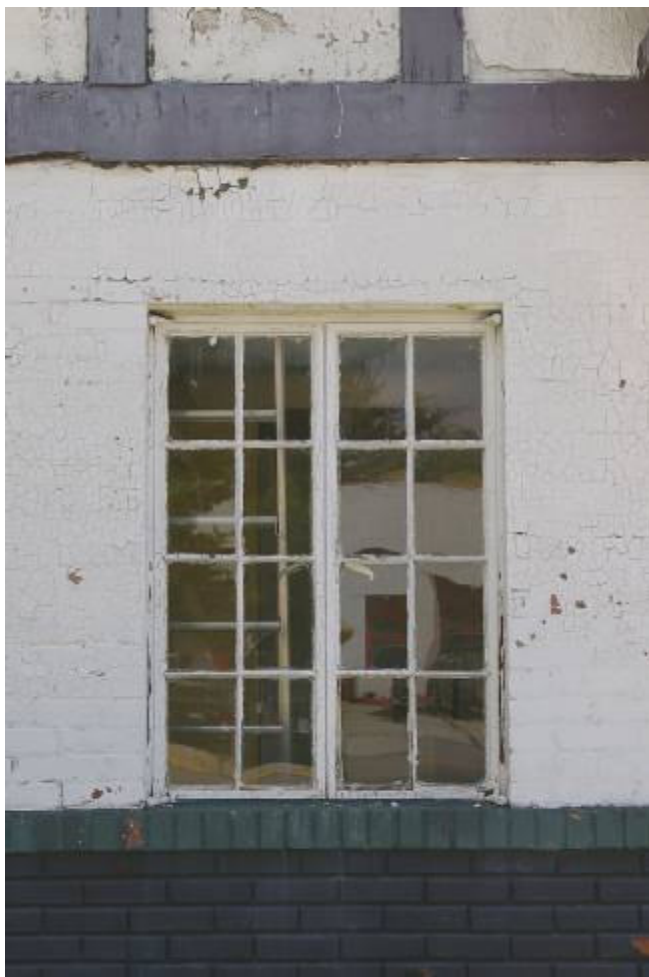
East casement window

Steel casement windows on the east and south sides of the original building consist of two hinged leaves, each leaf two panes wide by four panes high. The steel frames appear to be in good condition and the glass is intact. Glazing putty and paint are deteriorated. Paint build-up on the hinges and latches render the windows inoperable. A decorative plastic shutter adjacent to the south window is not original.

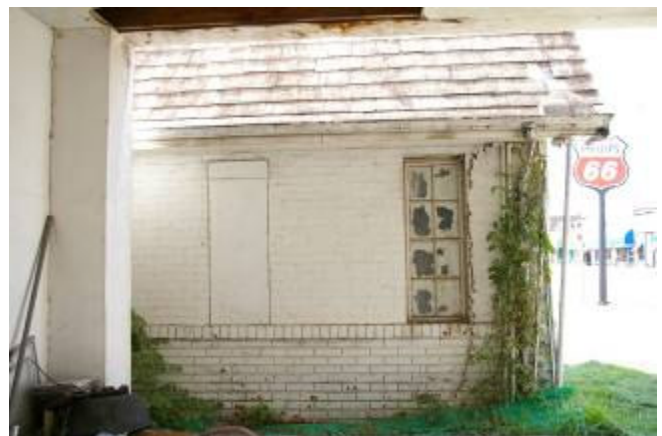
Men's room window on left, ladies' room on right

Two single-leaf steel casement windows open into the men's and ladies' rooms on the north side of the original building. Each window is two panes wide by four panes high. The steel frame of the ladies' room window appears to be in good condition and the patterned glass is intact, but largely covered with paint. Glazing putty and paint are deteriorated. Paint build-up on the hinges and latches render the window inoperable.

The men's room window is likewise intact, but is boarded over on the exterior and inaccessible for a complete inspection. From inspection of the interior of the window, the steel frame appears to be in good condition and the latch is intact. The patterned glass is painted over but intact.

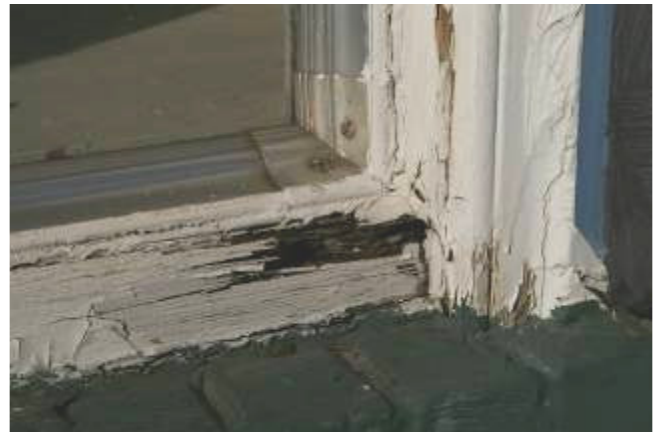
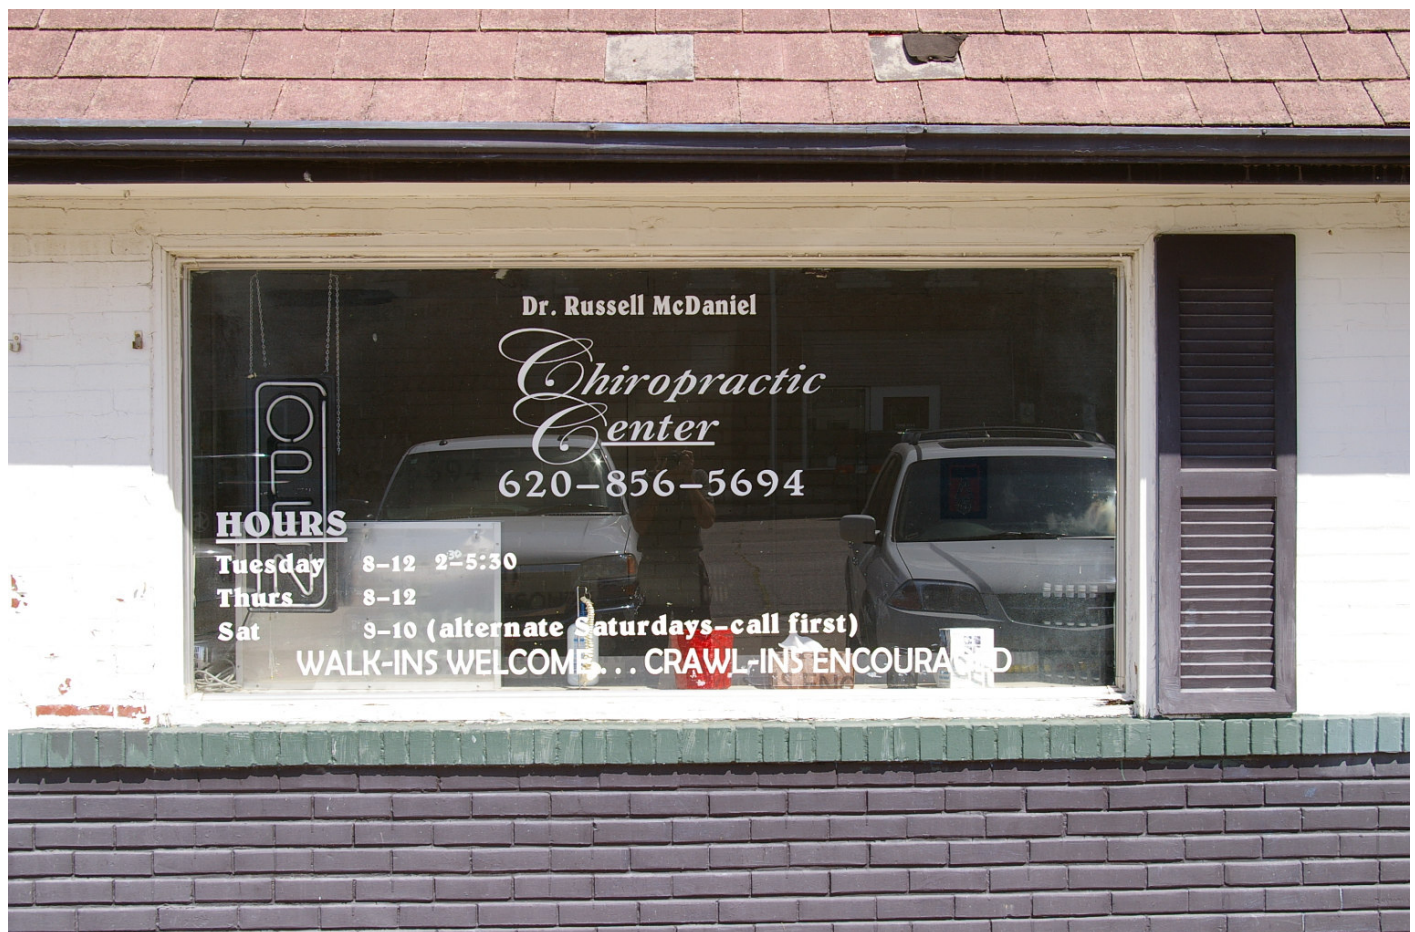
The large plate glass window on the south side of the addition is set in an aluminum frame and trimmed with wood. The glass is intact and the aluminum frame is in very good condition. The wood trim is generally in good condition, except for a rotted area at the lower east corner. Signage painted on the window is a recent addition. The decorative plastic shutter adjacent to the window is also not original.

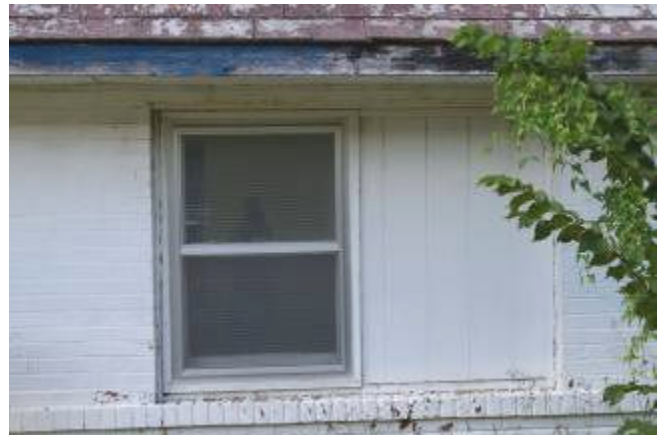
East garage window

On the west side of the garage are two aluminum double hung windows in a single opening. On the east side, there is a single aluminum double hung window which fills half of a larger opening, with the remainder of the opening walled in and surfaced on the exterior with painted wood paneling. These aluminum double hung windows are in good condition, but are not original to the building. The decorative plastic shutters on either side of the west window are also not original.

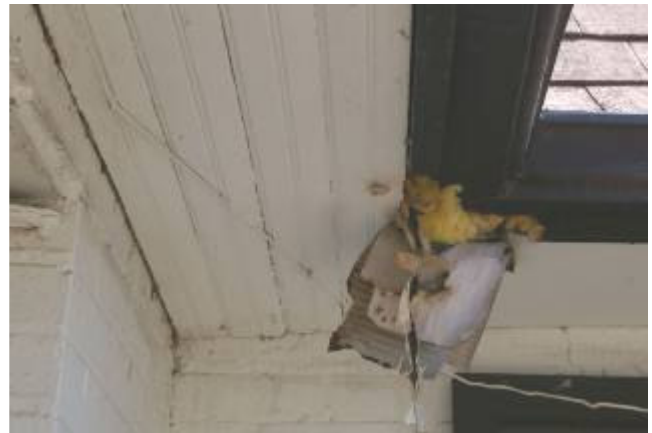
The beadboard soffits are generally good but weathered in places and the plywood garage soffit is in fair condition. There is a sizeable hole in the soffit below the inside corner of the addition. Gable and eave trim condition varies from good to poor, with the most significant weathering occurring at the northwest corner of the building and along both sides of the garage eave.

Soffit at inside corner of addition

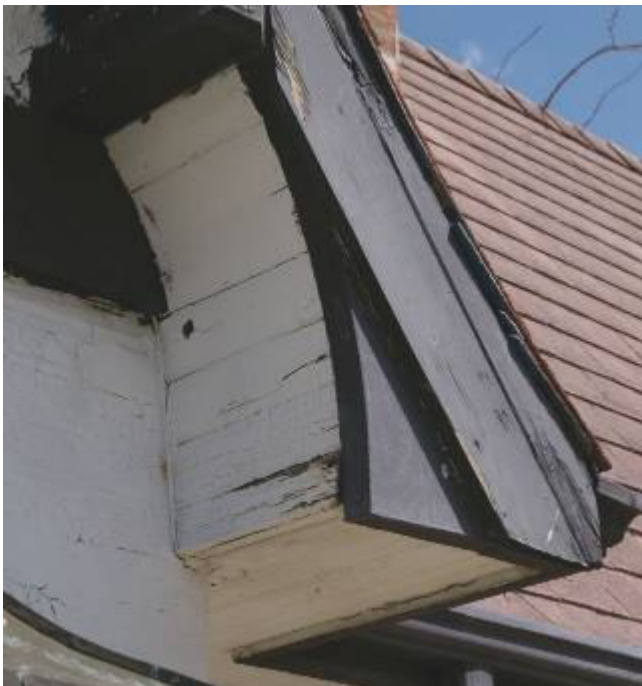
Soffit and gable trim over showcase window

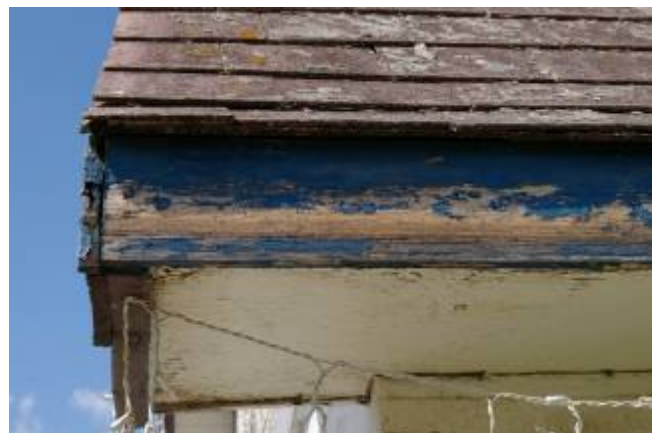
Soffit and trim at southeast corner of garage

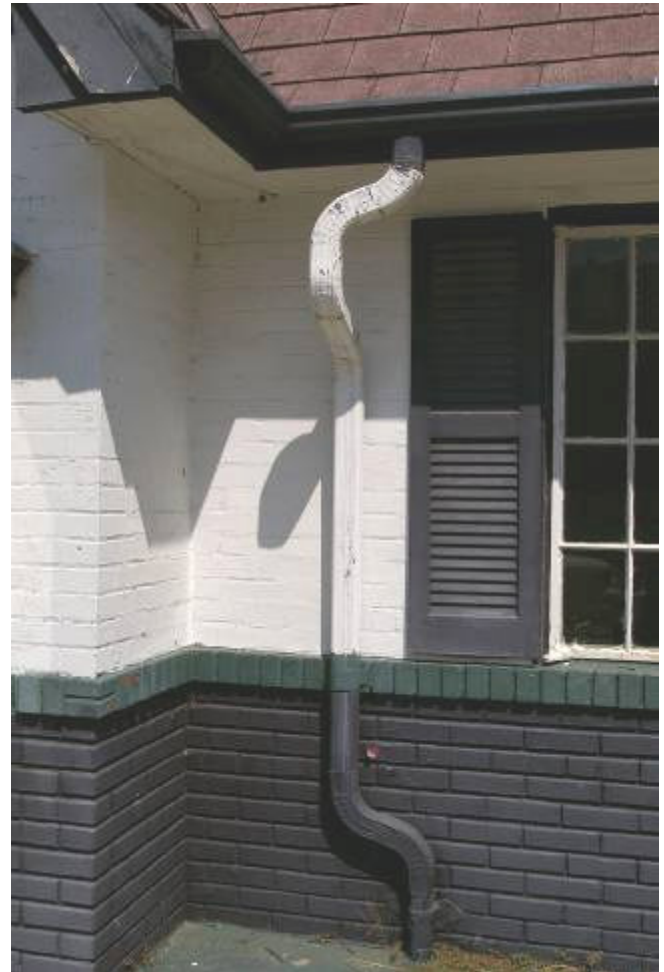
The sheet metal gutters on the original building are in good condition. The paint on the east and south gutters is also in good condition, but the paint on the north gutter has not been maintained and is in poor condition. The original downspouts are 2" diameter round pipe. The downspout at the northwest corner is intact, but in need of re-finishing. The upper part of the downspout at the southwest corner is in good condition but the bottom 3 feet is missing. The downspout on the south side of the original building has been replaced with a 4" x 3" sheet metal downspout and shifted over to allow for a decorative shutter.

Downspout on south side of original building

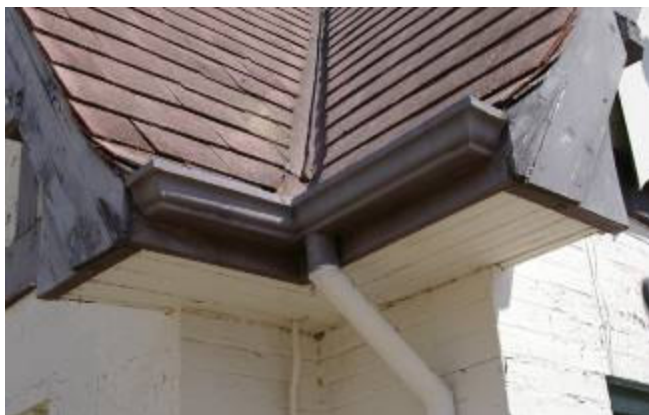
Gutter and downspout at southwest corner

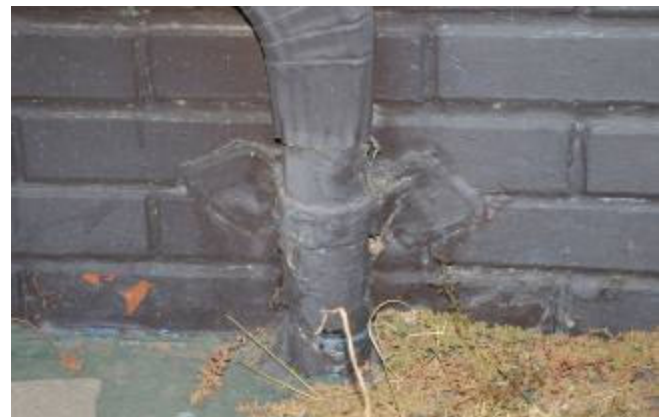
Some of the original downspout straps remain

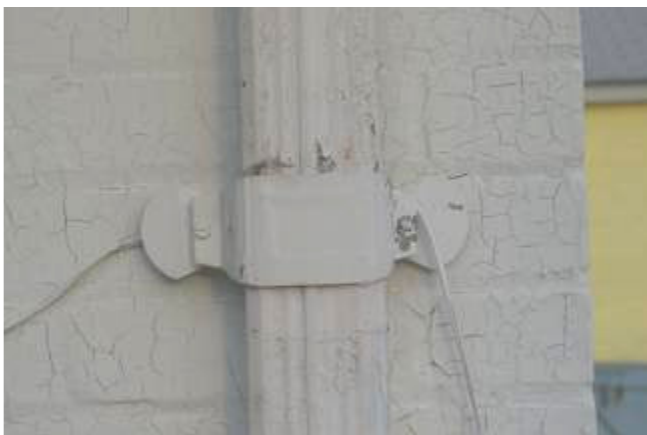
Downspout strap on garage addition

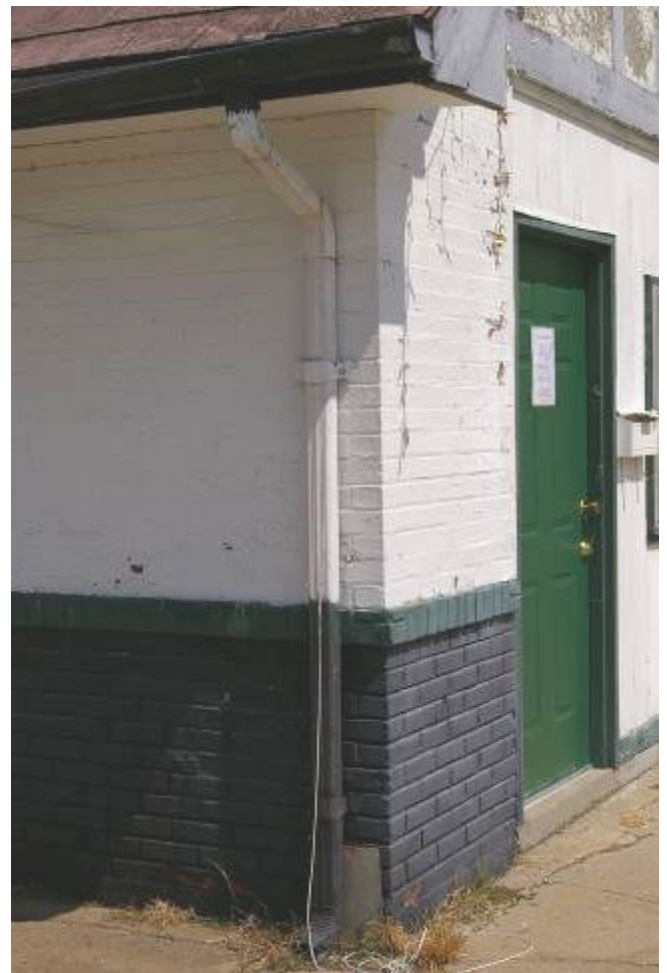
Gutter and downspout, southwest corner of garage

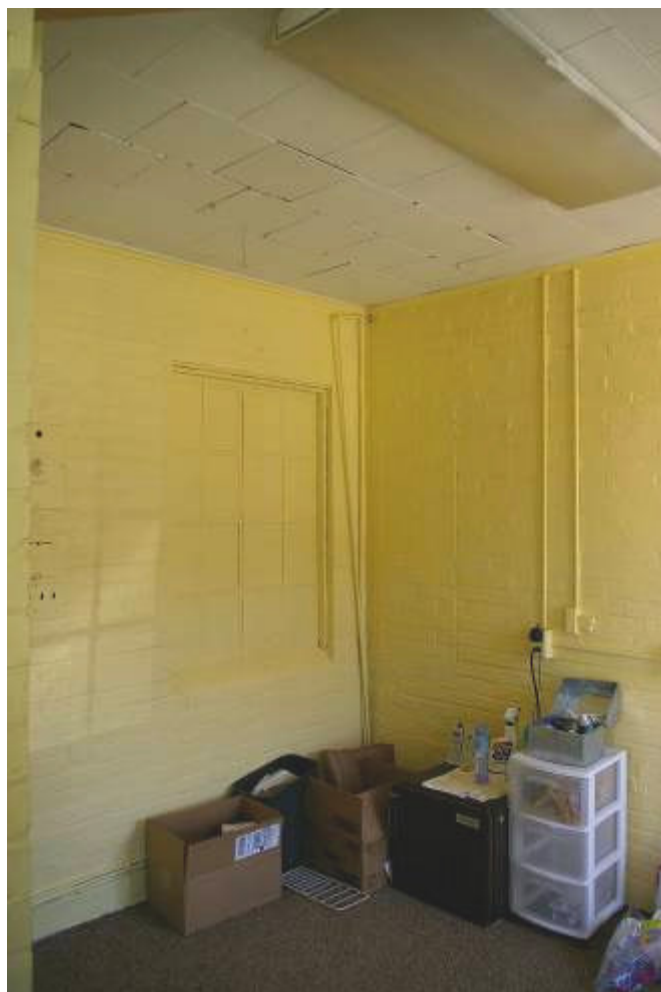
The office area of the original building has undergone some renovations. A wingwall partition has been added on the east side of the office space. It extends from the south wall and is crudely braced with a 2x4 to a wood shelf. The existing carpet flooring is in good condition. The original brick walls are virtually unaltered.

The original painted sheetrock ceiling is currently covered with 12x12 acoustical tile, which is in good condition. The fluorescent light fixtures and round air registers, which are in good condition, are also not original. Surface-mounted electrical conduit and outlet boxes are present on the east wall of the office. The opening to the chimney is covered by a round metal plate. An office heater would have originally been located within the room and vented into the chimney.

Office looking northeast

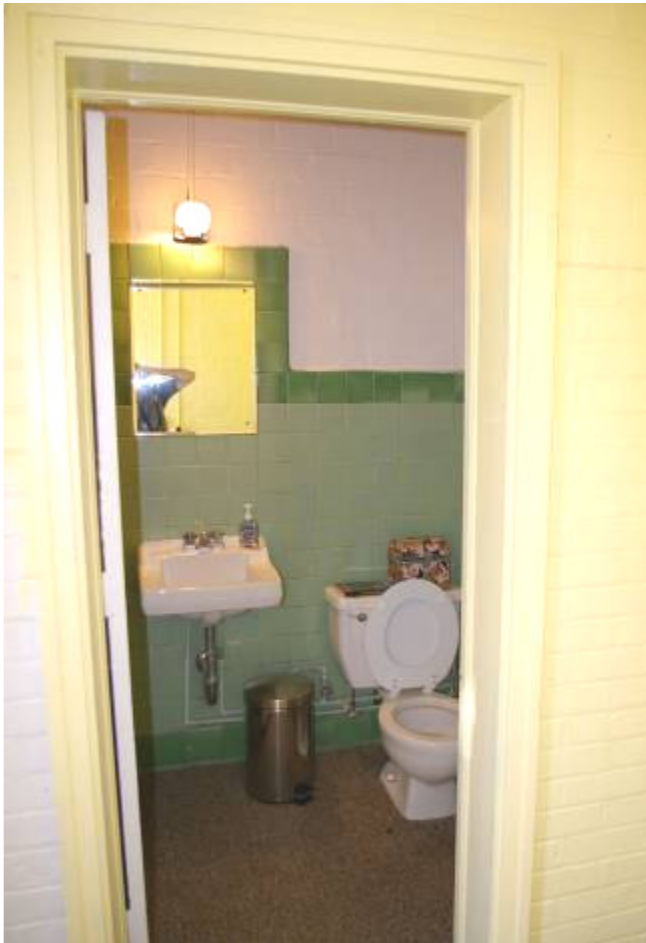
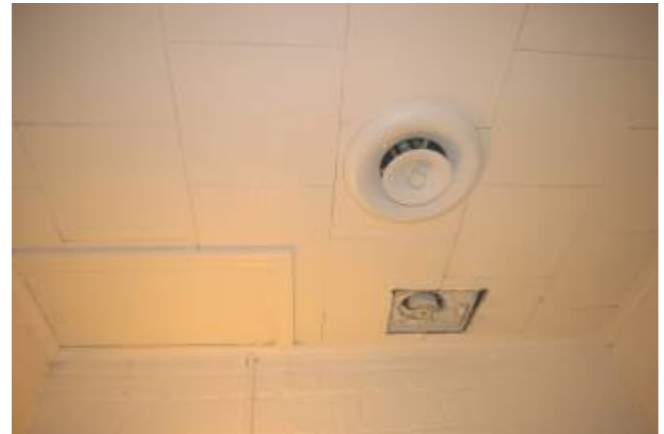
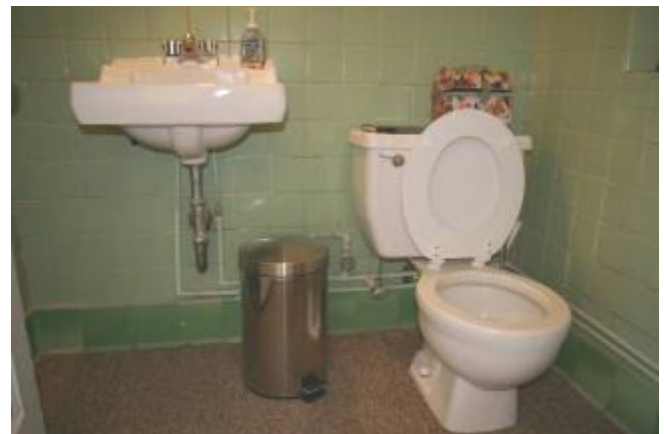
The plumbing fixtures in the former men's rest room of the original building are probably not original, but they are in good and functioning condition. The carpet floor covering is also in good condition. The green wall tile (actually baked enamel on metal) is typical of Phillips 66 stations and was probably installed when the station was remodeled in 1943. It is in good condition. Masonry walls above the tile are painted and in good condition.

The original ceiling, which included an attic access hatch, was painted sheetrock. The ceiling is currently covered with 12x12 acoustical tile, which is in good condition. The exhaust fan (cover missing) and round air register are also not original. The wall-mounted light fixture is either original or of early vintage and in very good condition. Accessories installed when the tile was installed include a mirror with beveled edges, integral ceramic tile toilet paper holder, and coat hook. The original panel door and frame are in good condition.

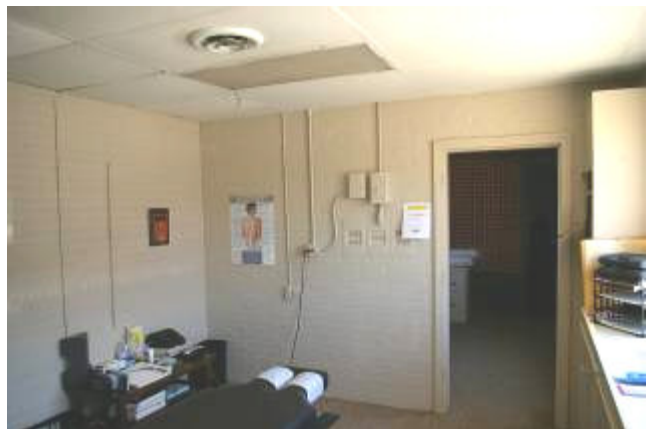
The existing carpet is in good condition and is installed over the original concrete slab. The painted masonry walls are in very good condition. The original sheetrock ceiling exists above the lay-in ceiling. It is in poor condition with much of the paint and paper facing peeling away. The original light fixture has been removed.

The cabinetry under the display window is in good condition, but it is not known whether it is original or a later addition. The doorway between the sales area and the office is cased in wood trim, which is in good condition. There may have been an exterior side door in this opening prior to the construction of the addition. The door has been removed from the doorway between the sales area and the garage. The wood door frame is in good condition. Surface-mounted electrical conduit and outlet boxes are present.

Sales area looking northeast

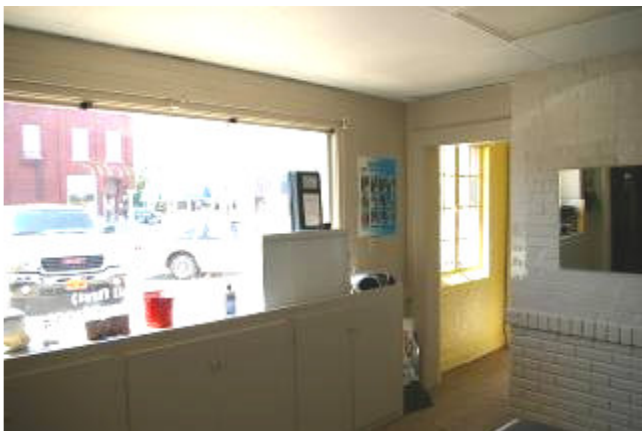
Sales area looking southwest

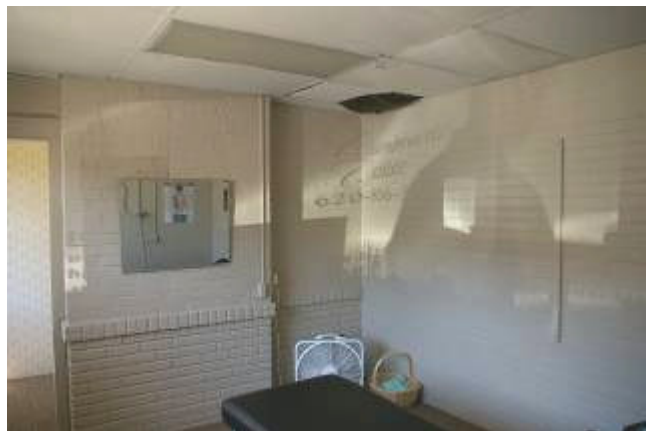
Sales area looking northwest

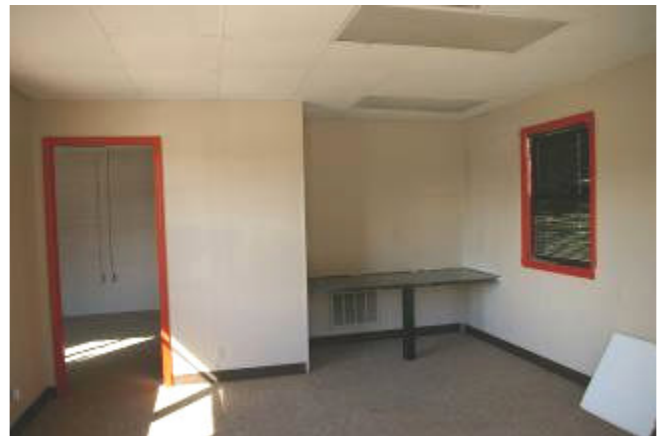
A concrete topping slab has been poured over the original floor slab in the southeast area of the garage, bringing the floor level with the northwest area, to which it connects via a doorway. The floor is covered with carpet, which is in good condition. The masonry walls on the east, west and south, the north partition, and the infill on the south side are covered with wallpaper. Above the lay-in ceiling, the original sheetrock ceiling is in fair condition, and the collars of three original light fixtures remain. There is a small closet in the southwest corner of this area.

Garage SE area, looking north

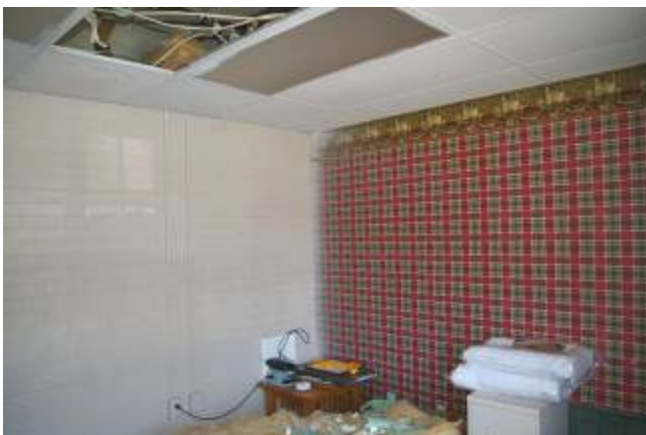
The original garage space has been divided by partitions into three areas. In the northwest area, a raised plywood floor has been built over the original concrete floor slab to bring the floor level with the adjacent sales and display area. The floor is covered with carpet, which is in good condition. The painted masonry walls on the north and west are in good condition. The south masonry wall and the east partition are covered with wallpaper. Above the lay-in ceiling, the original sheetrock ceiling is in poor condition, although one original light fixture remains intact.

Garage NW area, looking northeast

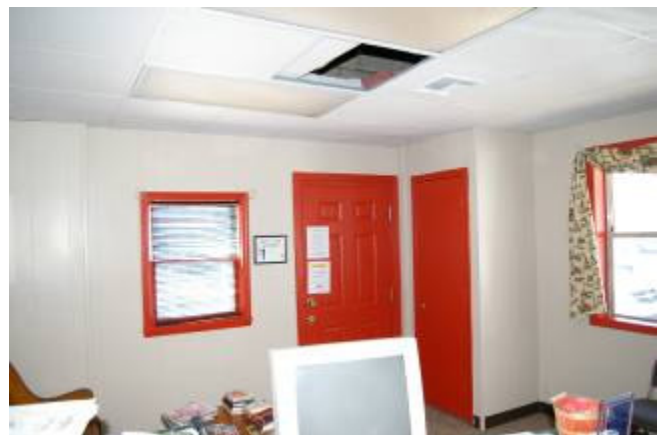
Garage SE area, looking southwest

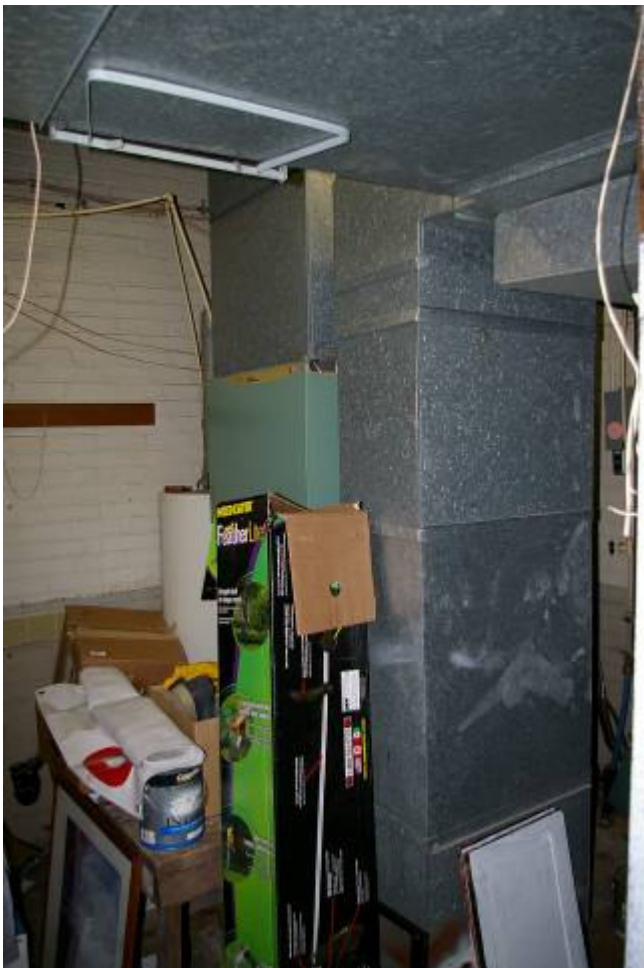
Garage – Mechanical Room

The northeast area of the original garage currently encloses the mechanical room. The air handling unit and water heater are set on a raised concrete slab in the northeast corner of the area. A portion of the original garage floor is visible in the remainder of the room, including a large floor drain. The masonry walls on the north and east are painted and in good condition. The original sheetrock ceiling is intact, but largely obscured by ductwork.

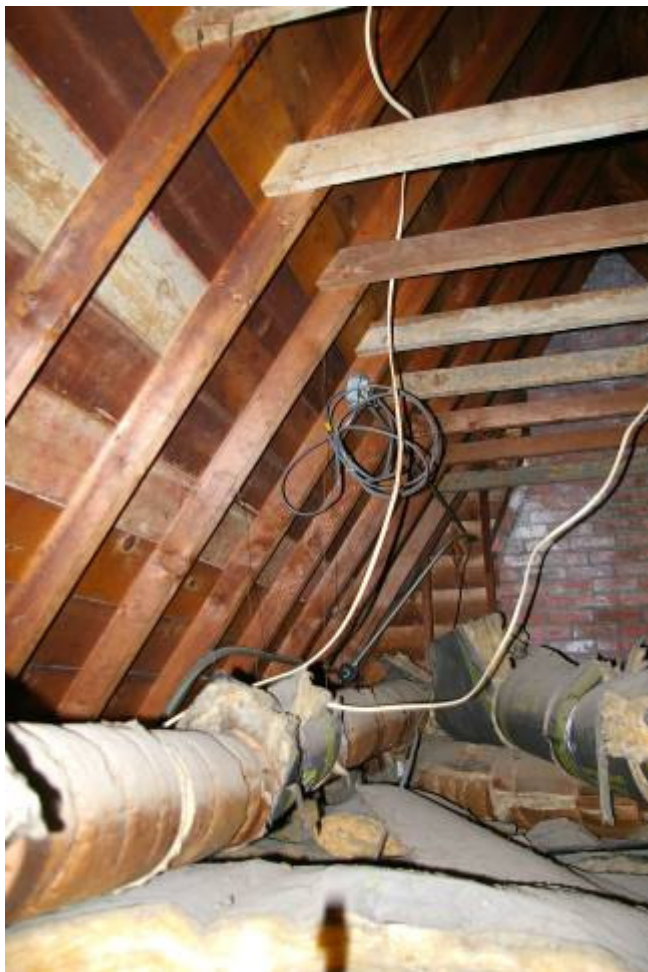
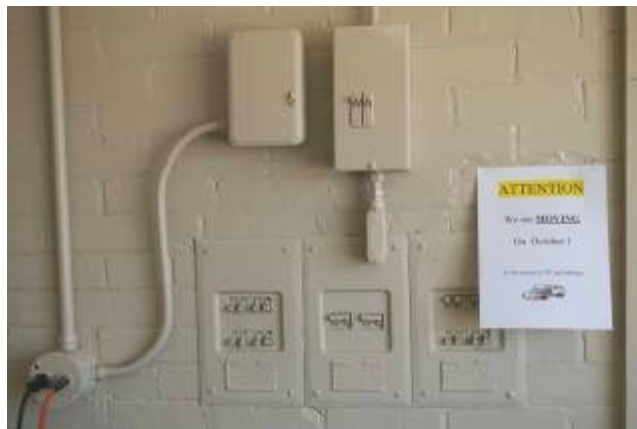
Electrical Systems

The original building contains a small fuse box on the north wall, which has been abandoned and re-wired to the newer service. The main electrical service and breaker boxes are located on the east wall of the sales and display area and were likely installed when the addition was built prior to 1942. The building has received upgrades to its electrical systems in more recent years, including fluorescent lighting and surface-mounted outlets.
