National Register of Historic Places Registration Form

historic name Harry Keith Barn
other names/site number KHRI # 065-199

street & number 200th Avenue & M Road (1/2 miles E of Avenue 200 on M Road) not for publication
city or town Penokee vicinity
state Kansas code KS county Graham code 065 zip code 67659

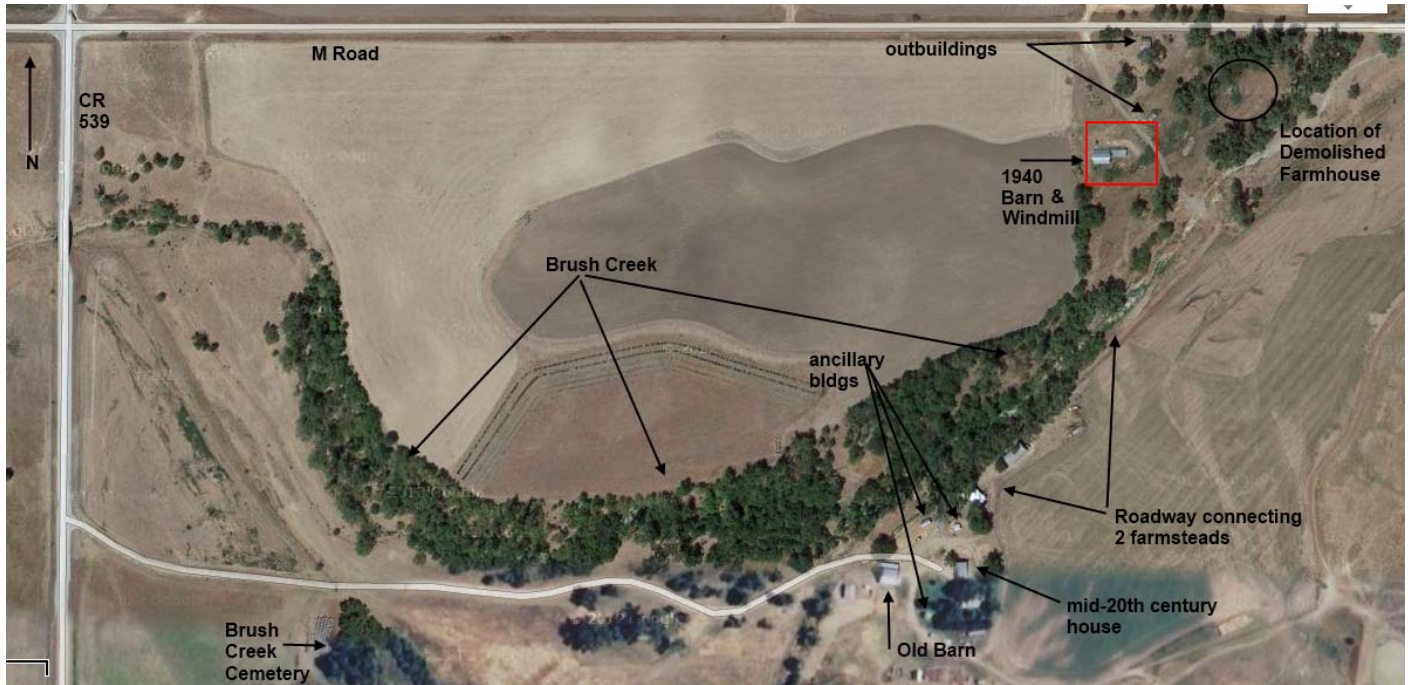
Figure 1:

Aerial Image (Google.com, 2012)
Box indicates nominated barn & windmill.

The Harry Keith Barn is located south of Penokee in Millbrook Township, Graham County, Kansas. It is situated in the northeast quarter of Section 2, Township 9S, Range 24W and is southeast of the junction of 200th Avenue and M Road. It was constructed in October 1940 on Harry Keith's farmstead, which he had owned since purchasing it from F.G. Brumage in 1920. The impressive gambrel-roof bank barn and adjacent windmill can be seen from the main county road (200th Avenue). The environs of the barn include rolling agricultural fields, century-old cottonwood trees along nearby Brush Creek, and hedge trees. Aside from the barn and windmill, the site of the associated farmstead includes a few remaining outbuildings, but they are not within the boundaries being nominated. The two-story stone farmhouse has been gone for many years, and the barn and remaining outbuildings are now associated with the farmstead located in the northwest quarter of Section 2. (Figure 1)

The quarter section to the west of Keith's barn reflects some of the area's earliest settlement history – primarily in the form of a pioneer cemetery. The Brush Creek community and the cemetery were sometimes referred to as Turnerville – named after the Turner family that settled there. Simeon Turner and his family settled the adjacent quarter section, and they are first noted in the 1879 census of Graham County. Approximately 20 graves have been recorded in the Brush Creek Cemetery, many of the area's earliest residents (Knoufs, Turners, Beeber, Biddle, etc.) No Keiths are buried there as they were not associated with the surrounding property until 1920.⁶ (Figure 1)

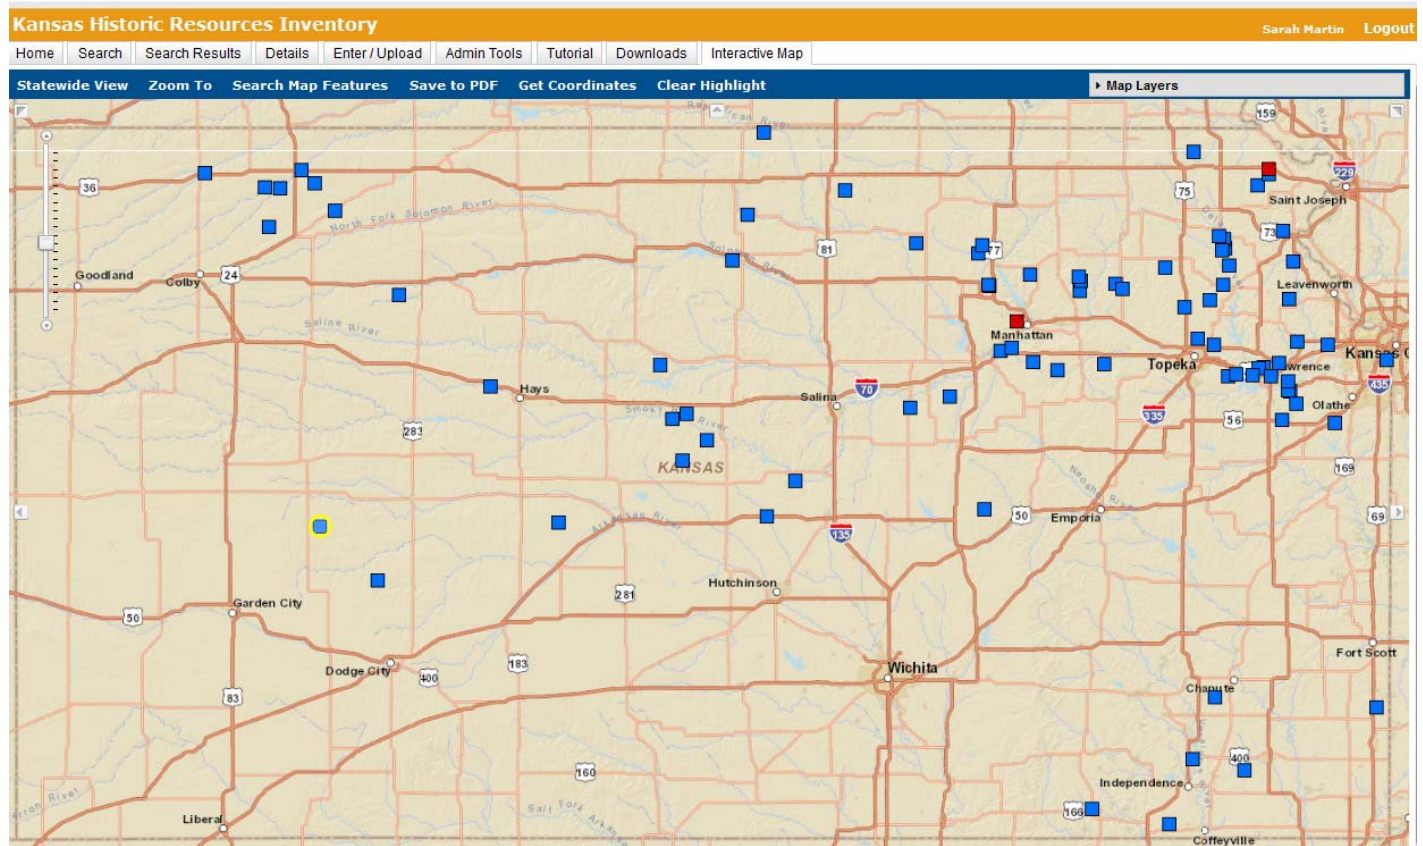
Figure 2: Map of Bank Barns Surveyed in Kansas
Kansas Historic Resources Inventory, Kansas Historical Society
Online Database accessed 19 November 2012: <http://khri.kansasgis.org>

Eighty-five Bank Barns are noted in the Kansas Historic Resources Inventory (Figure 2), 53 of which were recorded during a 2007 survey of 300 agricultural properties in Kansas. Although the survey determined that Bank Barns are common throughout Kansas, “they predominate in the early-settled counties of Eastern Kansas.”²³ There are sixteen of these barns in Doniphan County listed in the National Register as part of the “Byre and Bluff Barns of Doniphan County” multiple property nomination. Many early Kansas Bank Barns were built by settlers of Pennsylvania-German heritage, but “the bank design gained favor with farmers of all ethnic backgrounds,” and remained popular into the mid-20th century.²⁴

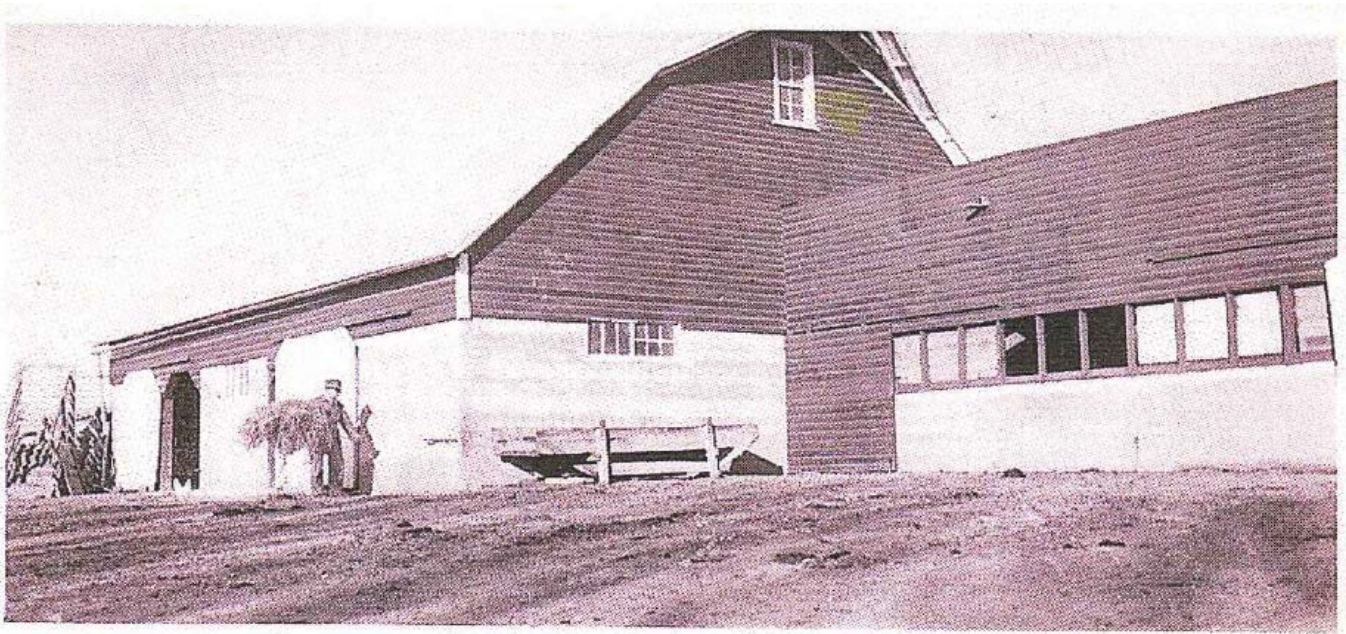
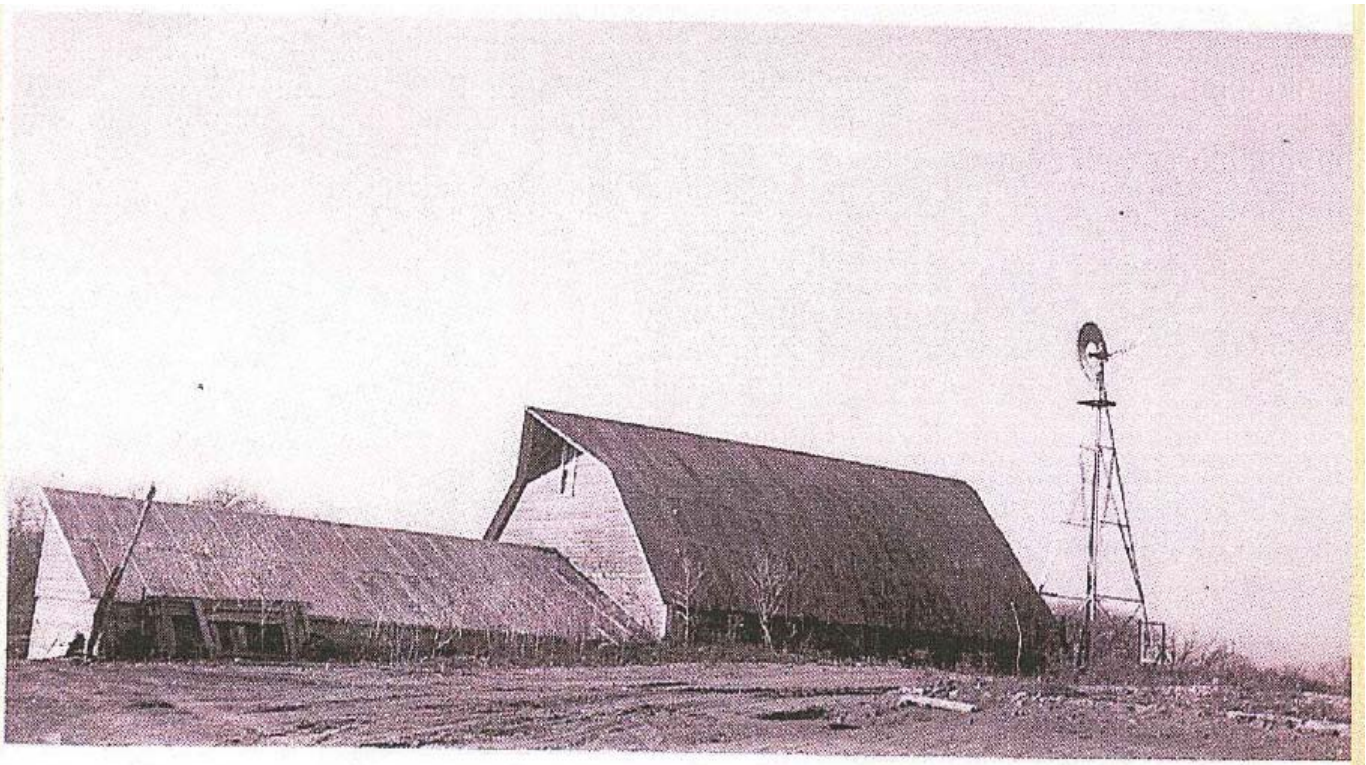
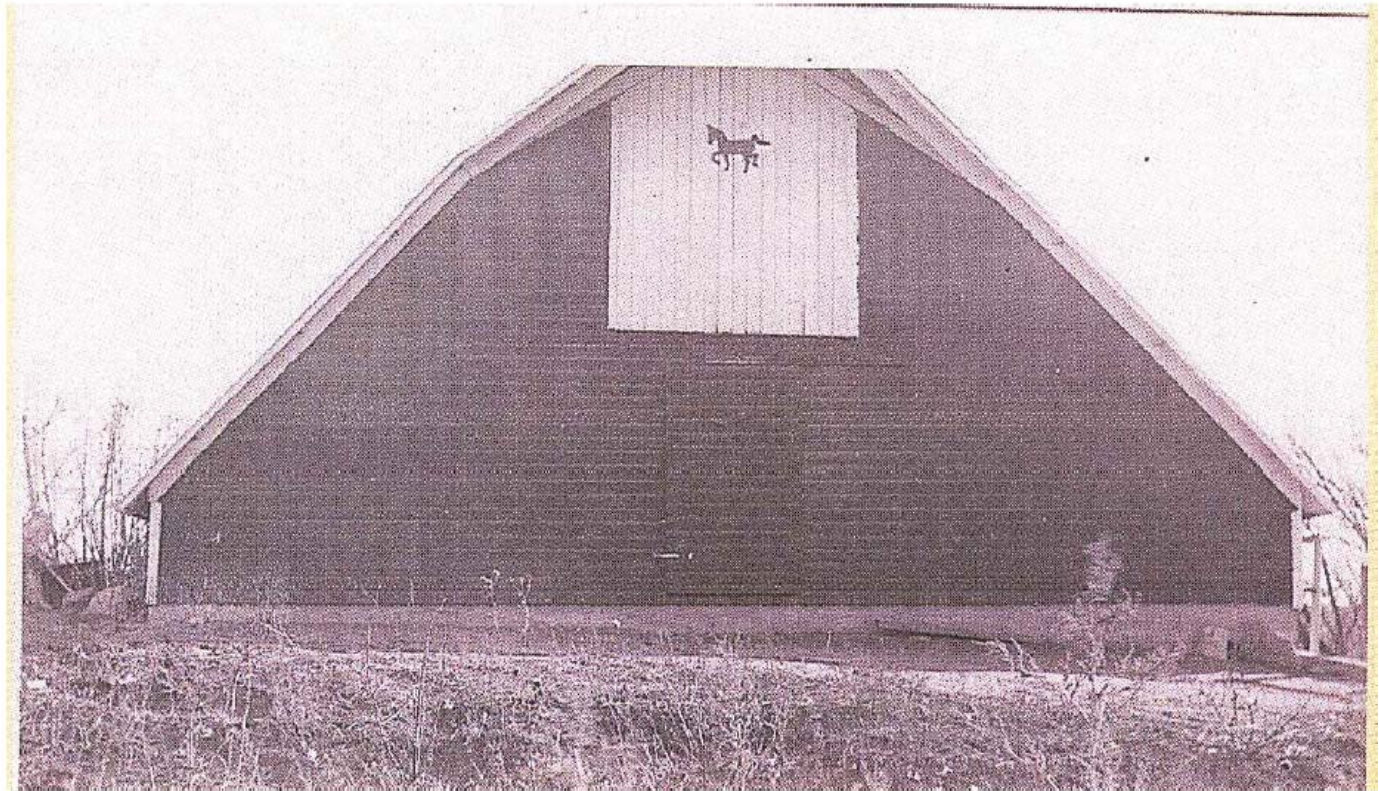
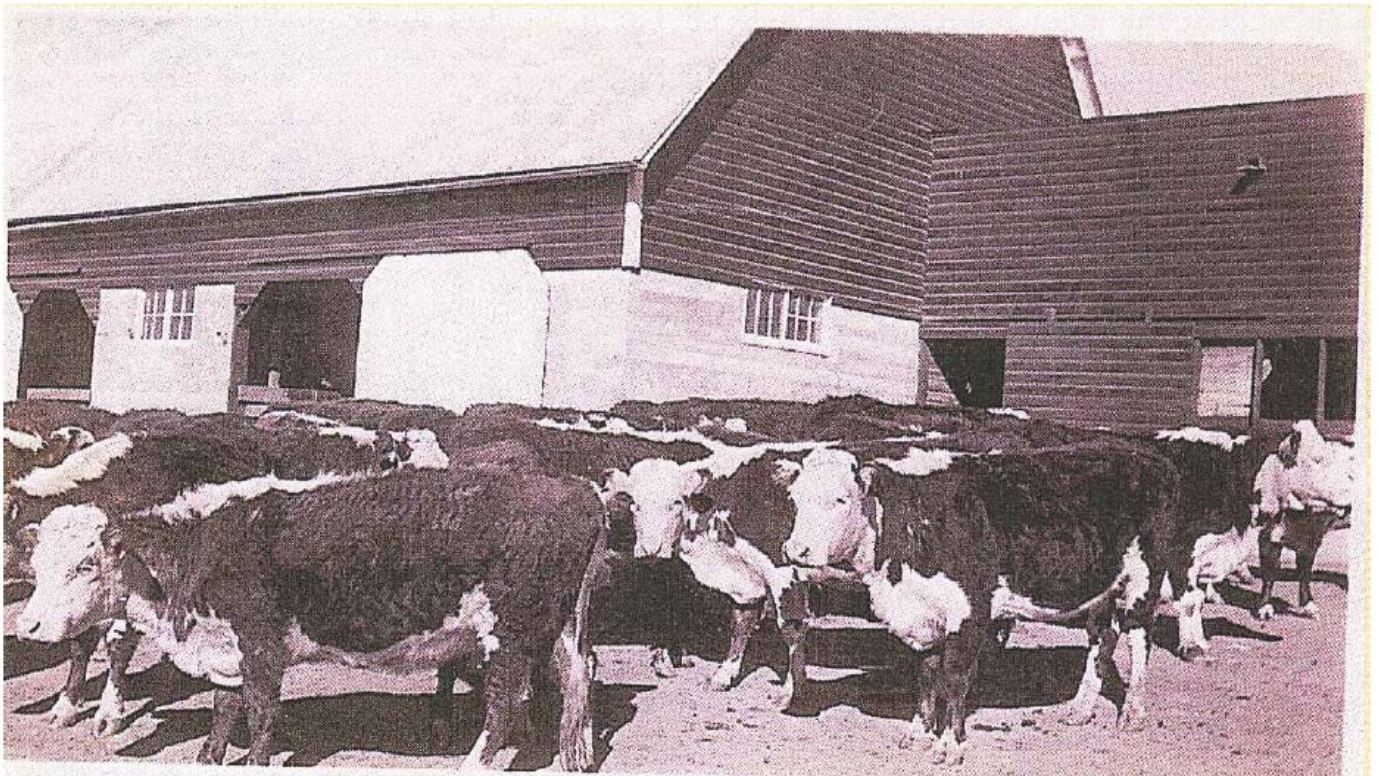
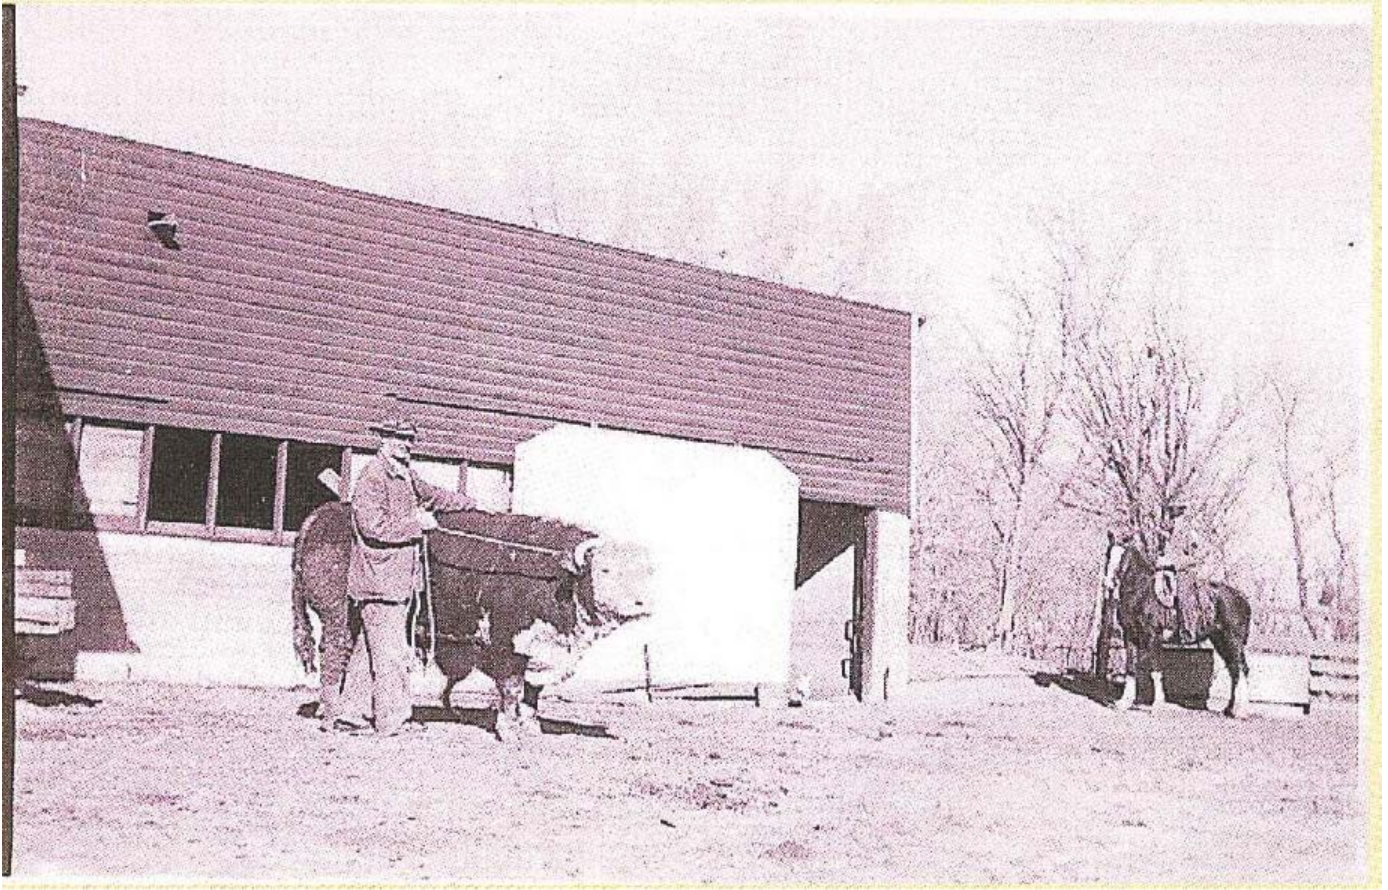
Figure 4: Keith Barn, early 1940s. Photographs Courtesy of property owner Diana Nickelson.

Figure 5: Keith Barn, early 1940s. Photographs Courtesy of property owner Diana Nickelson.

Figure 6: Keith Barn, early 1940s. Photographs Courtesy of property owner Diana Nickelson.

Figure 7: Keith Barn, early 1940s. Photographs Courtesy of property owner Diana Nickelson.

Figure 8: Keith Barn, early 1940s. Photographs Courtesy of property owner Diana Nickelson.

The Keith Barn was built in October 1940 by Harry Keith (1893-1961), his brothers, and neighbors. At the time of construction, it was painted red with white trim and included a painted trotting horse on the west-facing hay door. (Figure 6) It has always had a roof made of tin. The barn is two stories and is built into a hillside allowing ground-level access to the upper and lower floors. The barn is distinguished by its broad gambrel roof, and it includes a one-story rectangular wing with a shed roof extending from the barn's east elevation. The shed roof slopes downward to the north nearly touching the ground. The foundation and lower walls of the barn and wing are constructed of poured concrete. The upper walls are wood framed and clad in horizontal weatherboard. Based on historic photographs and an assessment of the building's materials, the barn and one-story wing appear to have been built at the same time. (Figures 4 through 8)
